**COTTAGE GROVE ADVISORY COMMITTEE  
ON HISTORIC PRESERVATION**

**MINUTES**  
**CITY OF COTTAGE GROVE**  
**ADVISORY COMMITTEE ON HISTORIC PRESERVATION**  
**June 10, 2025**

***Cardenio Severance (Cedarhurst) Mansion CUP Proposal by Bellagala***

Cordenio Severance House Development Diagram

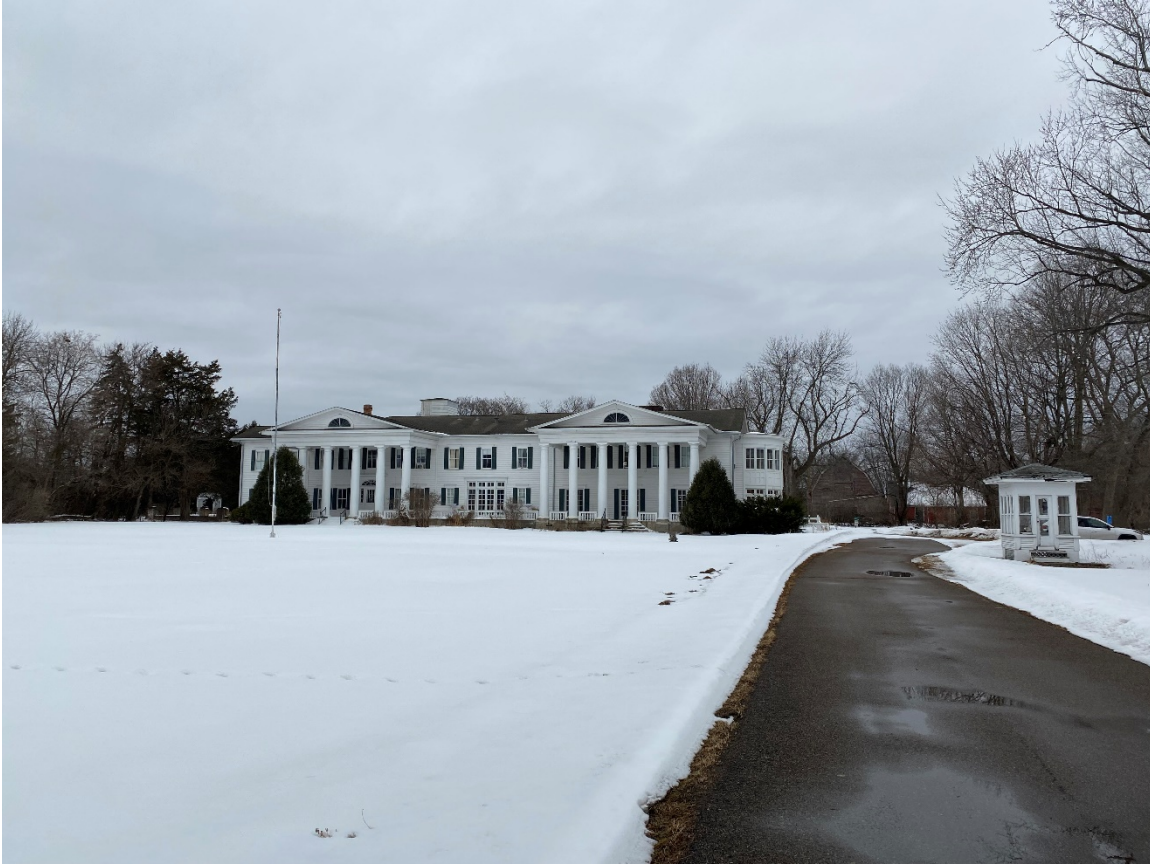
**Photo 3.** View of east elevation of Severance House (Wing A), looking west.

- 1) A large, cross-gabled wing (**Wing A**) with a basically rectangular plan and concrete foundation comprises the majority of the existing house (**Photo 3**). The south half of this wing was likely constructed sometime in the late 1800s or early 1900s and may have been completed as two separate additions. The north half of **Wing A** is the 1917 addition.
- 2) A small, cross-gabled wing (**Wing B**) with an irregularly-shaped plan and stone foundation is attached to the west (rear) elevation of **Wing A** (**Photo 11**). Given the vernacular, simple style of this portion of the house and its stone foundation, this may have been the original farmhouse constructed in c. 1867.

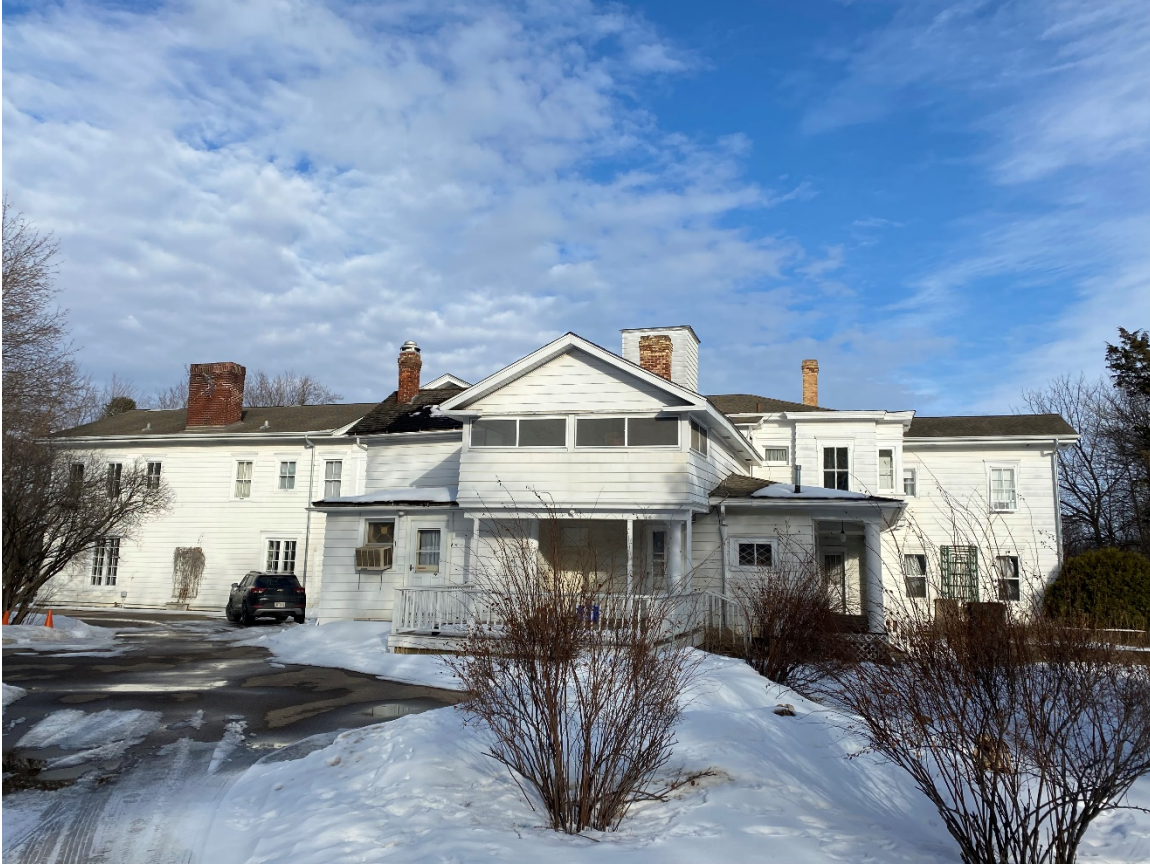
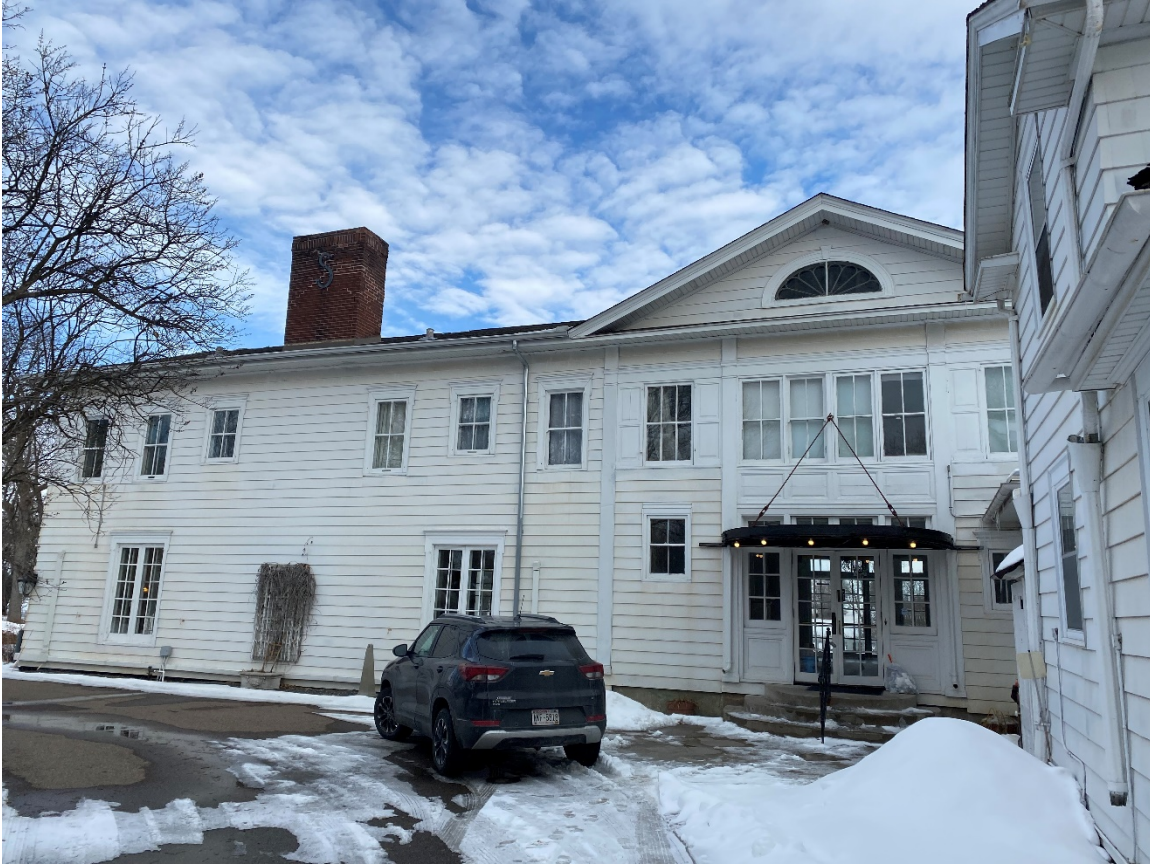
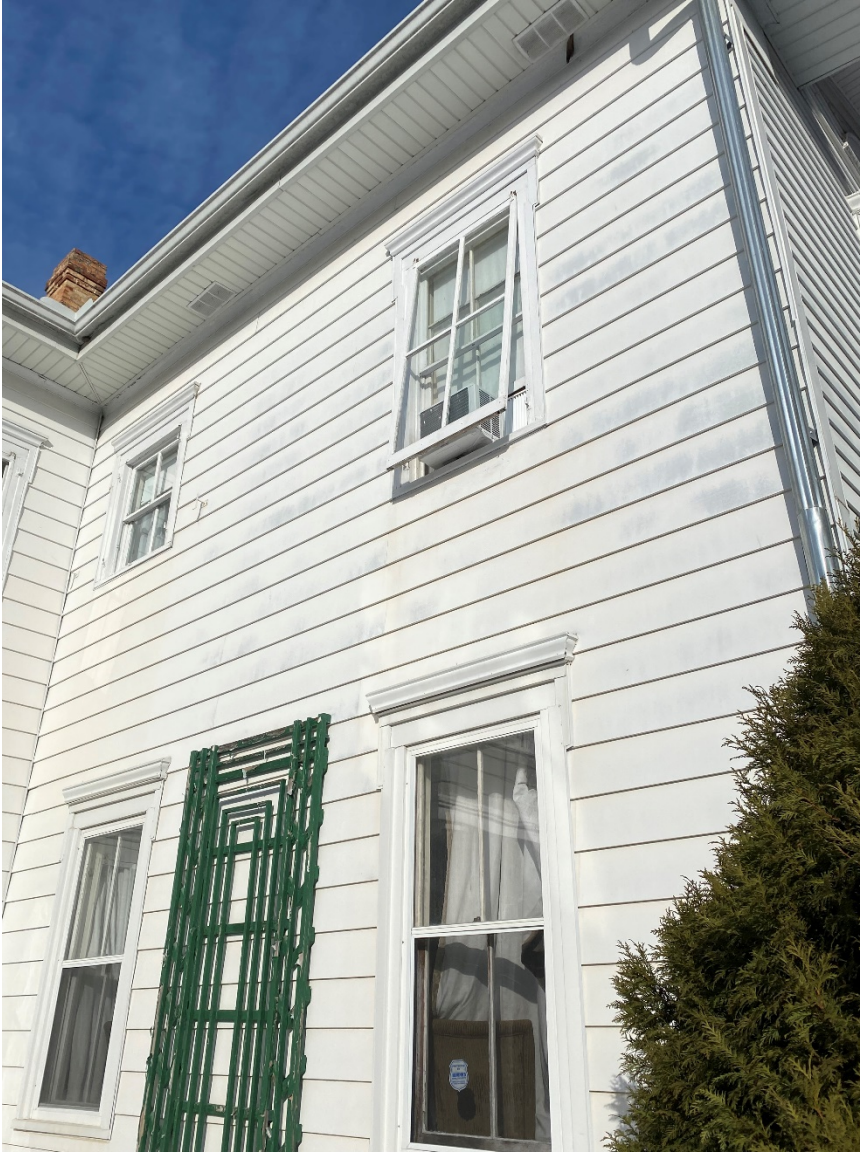
Photo 11. View of west elevation of Severance House, looking east.

Photo 12. View of west elevation of Severance House (Wing A), looking east.

**Photo 16.** View of west elevation of Severance House (Wing A), looking northeast.

*Wing A: West Elevation (Photos 11, 12, 16)*

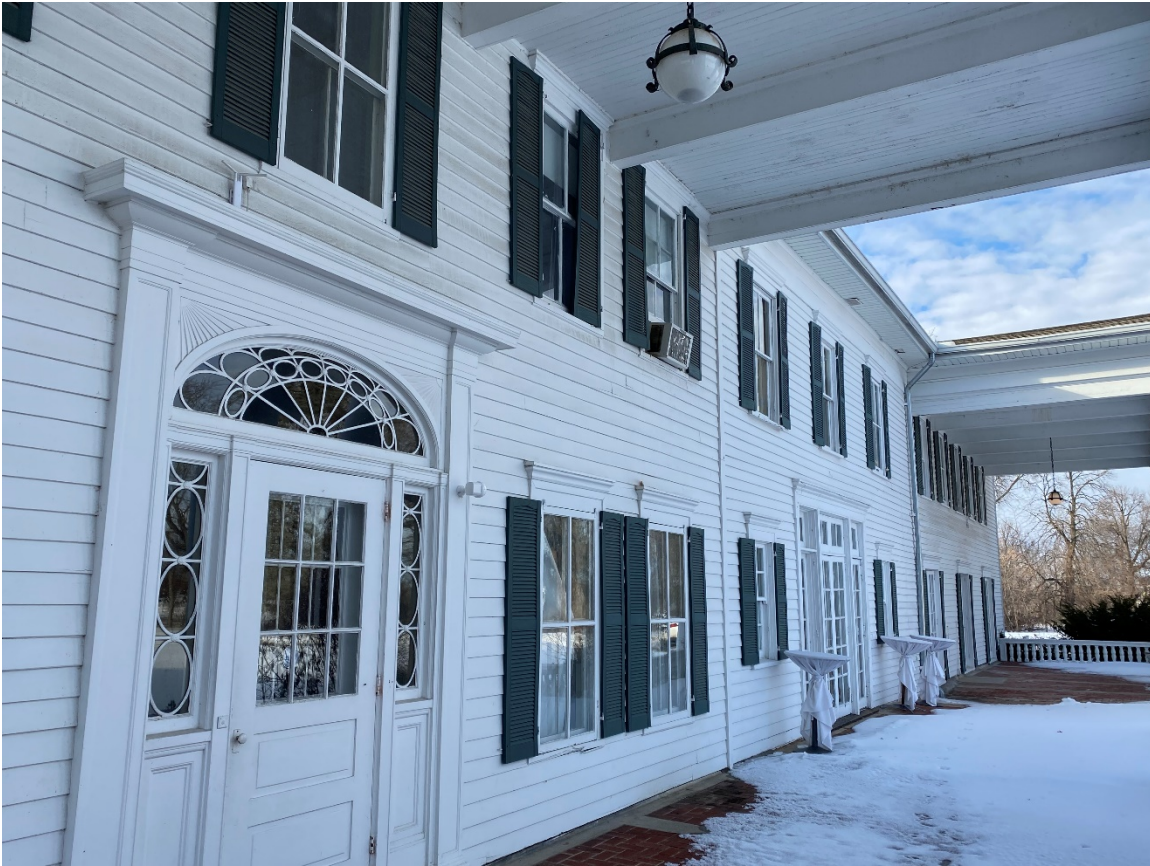
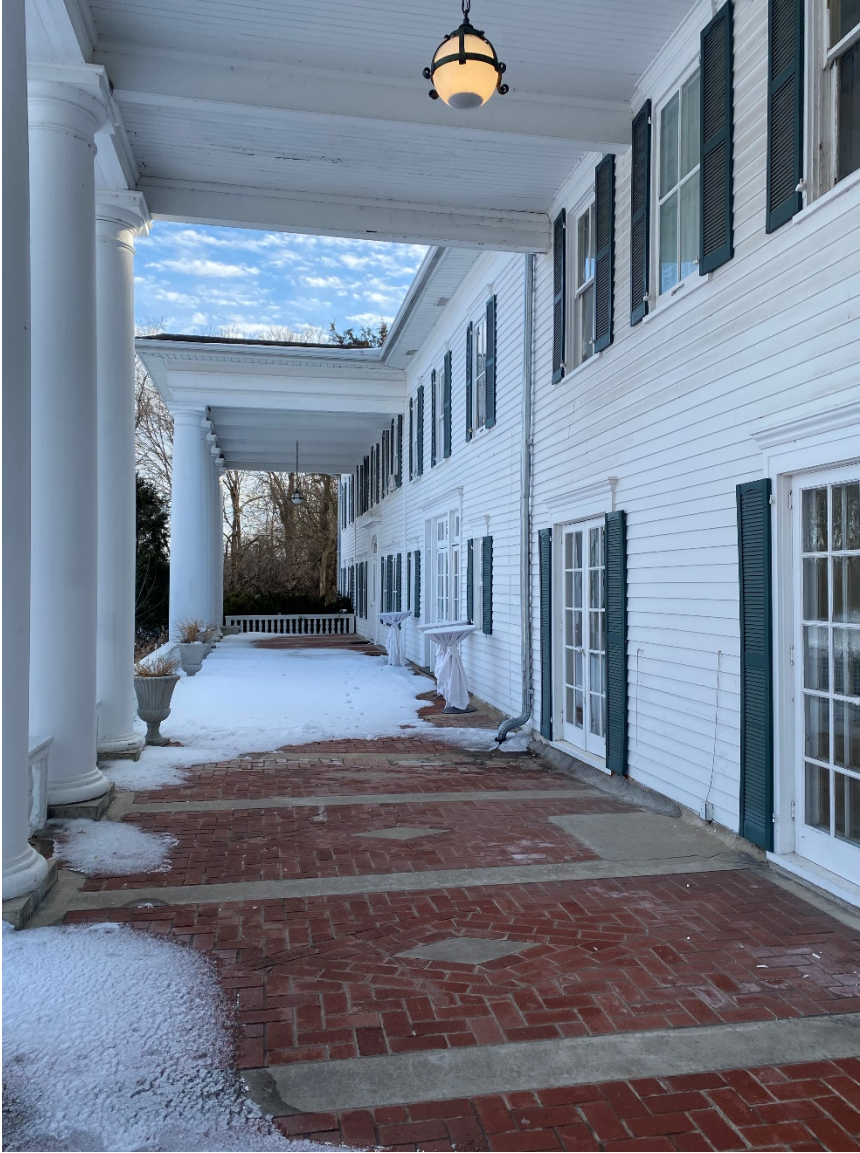
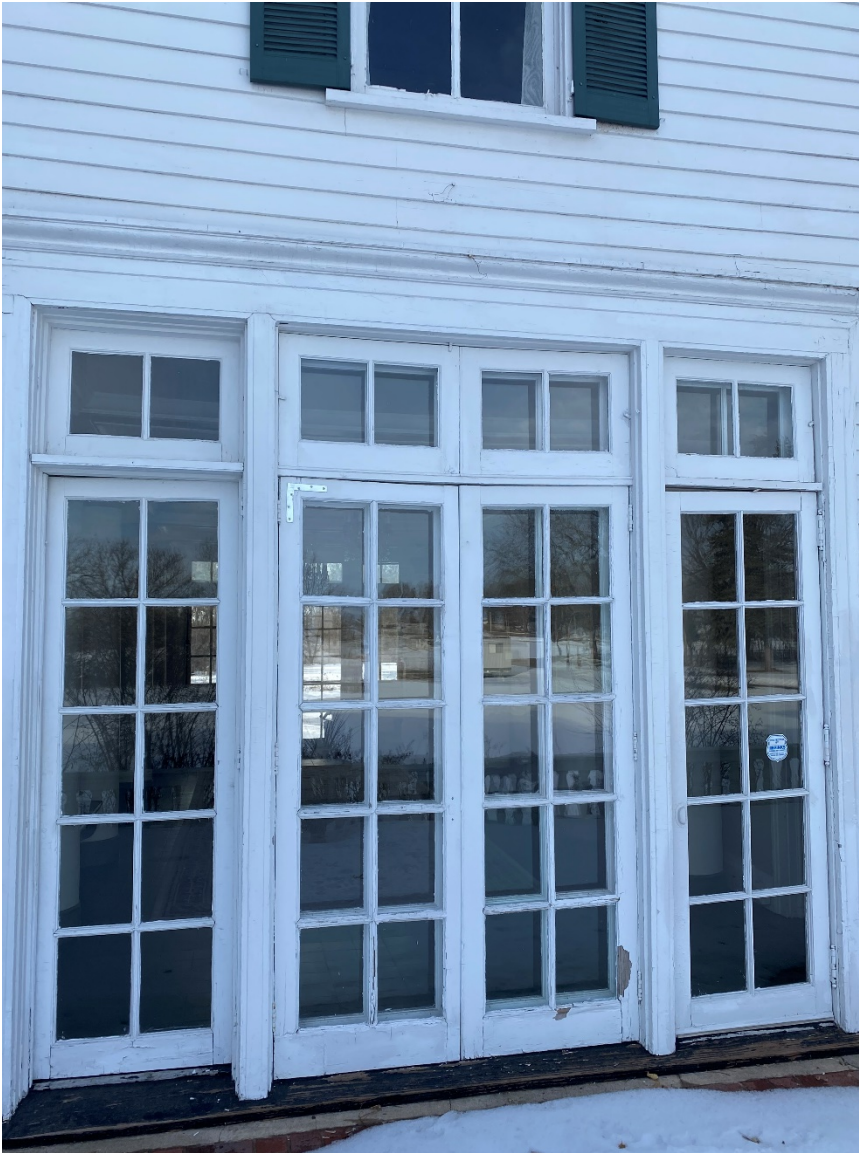
**Photo 18.** View of east elevation of Severance House (Wing A), looking northwest.

Photo 19. View of east elevation of Severance House, looking southwest.

Photo 20. View of central entrance on east elevation of Severance House, looking west.

*Wing A: East Elevation (Photos 3, 18 - 20)*

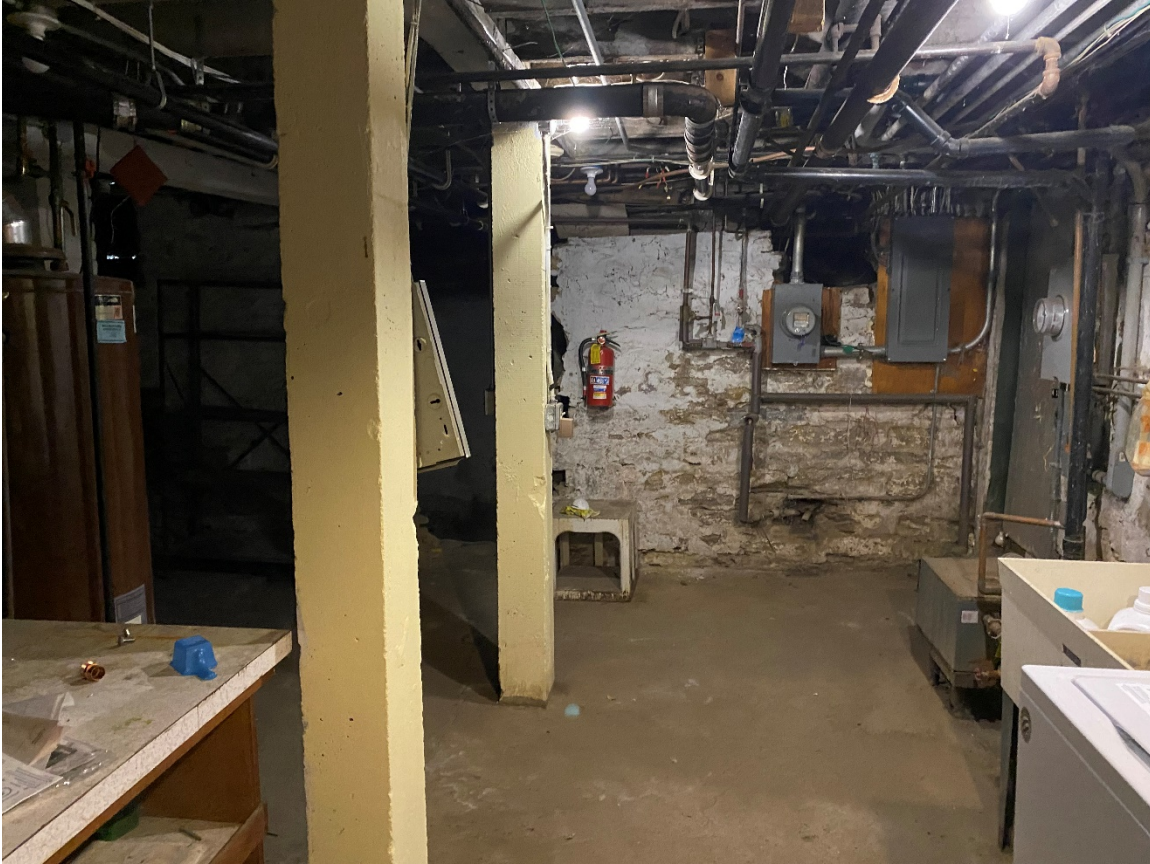
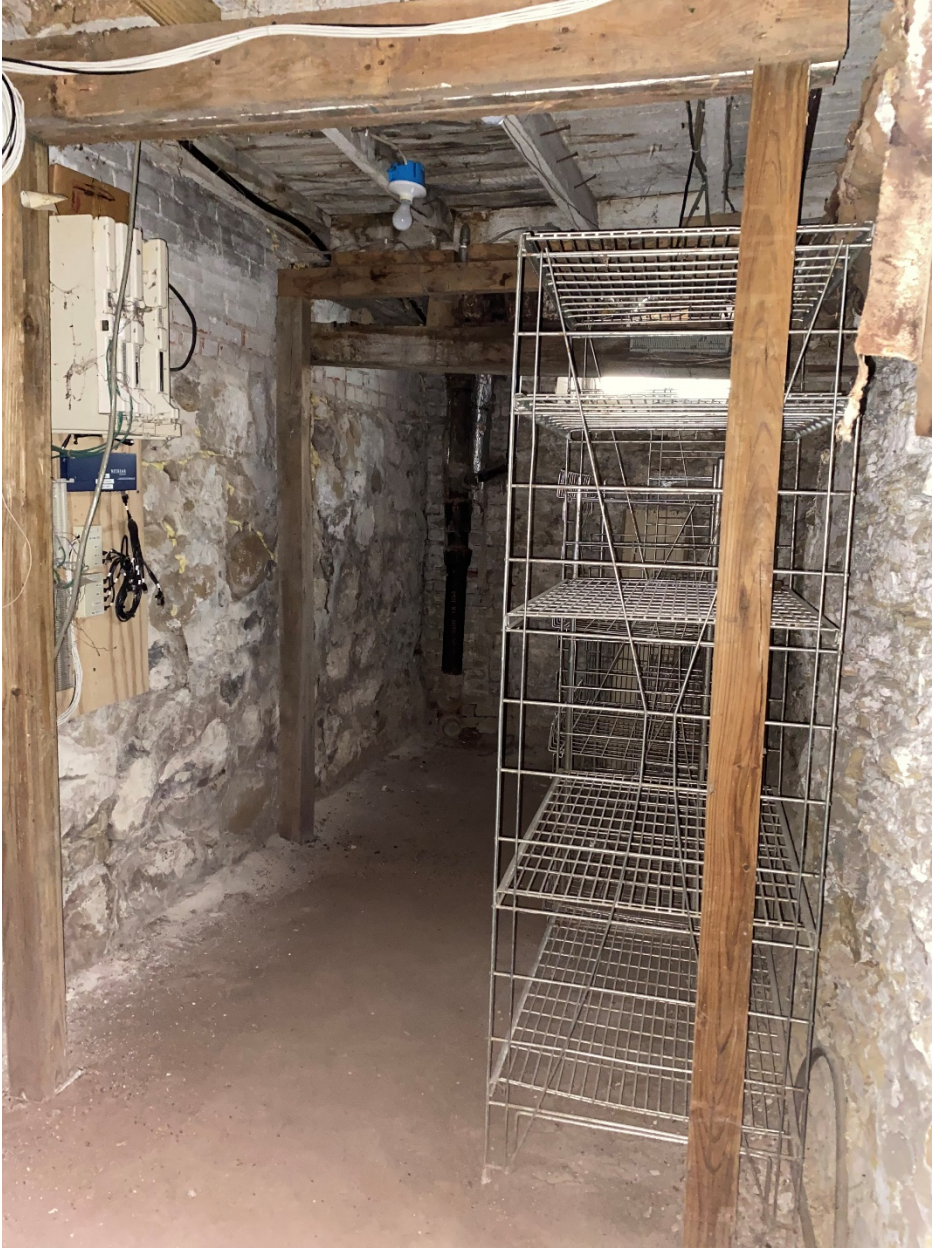
Photo 21. View of lower level of Severance House (Wing B), looking south.

**Photo 22.** View of lower level of Severance House (Wing B), looking south.

The lower level is accessed from the exterior via the non-historic stair addition at the north side of Wing B. At the lower level, Wing B has stone foundation walls, most covered with a parge coat, and exposed concrete and wood structure (**Photos 21 and 22**). The upper portion of the south foundation wall is composed of brick. A brick chimney is located near the center of this wing. One window is located on the west wall. Another window located on the east wall no longer fulfills its intended purpose as the east wall is currently located beneath Wing A. Exposed piping and conduit and several wood doors were observed throughout.

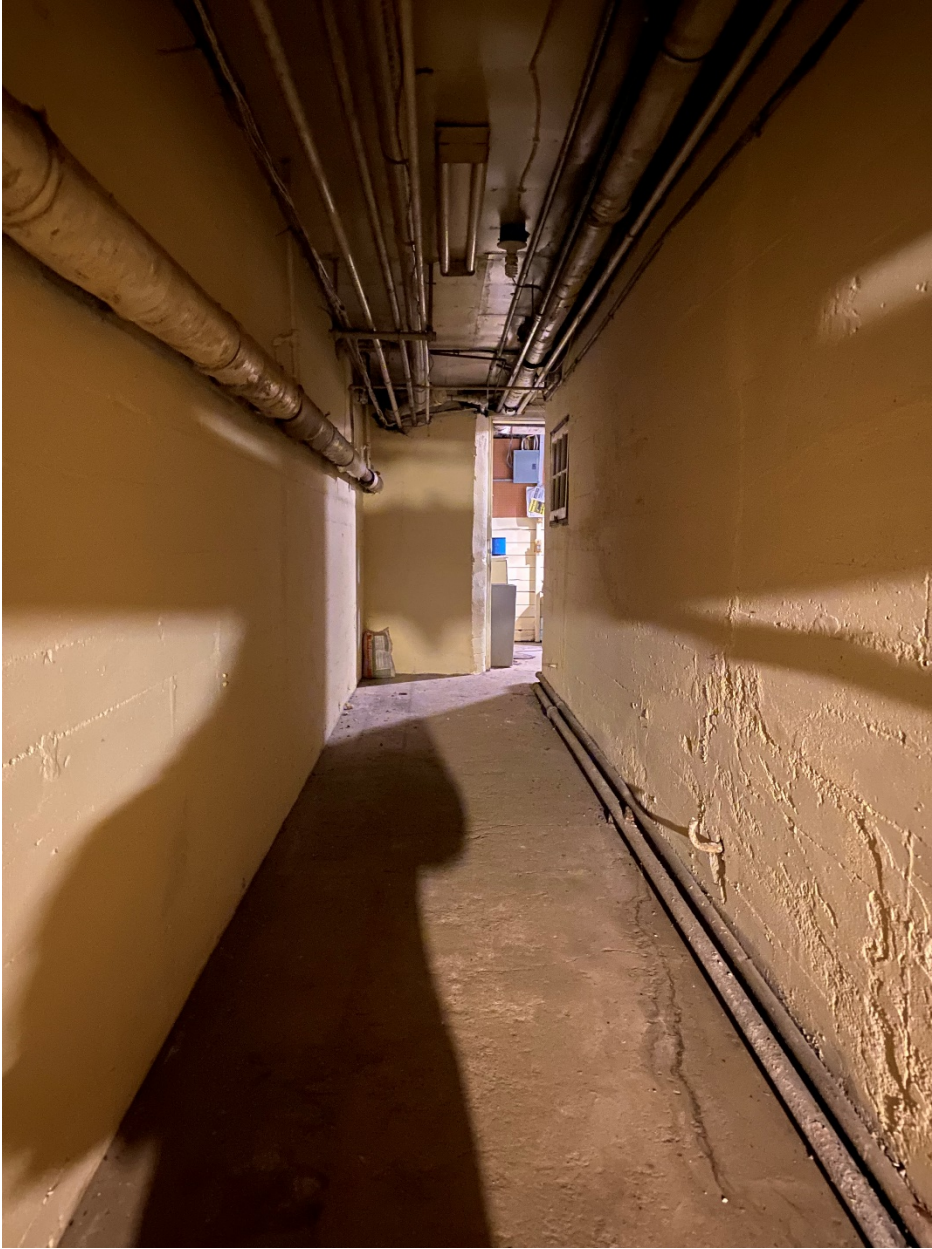
**Photo 23.** View of tunnel between Wing B and Wing A at lower level of Severance House, looking east.

At the north side of Wing B, a concrete tunnel running north-south (**Photo 23**) connects the original c. 1867 house to the basement of the 1917 addition (Wing A). Only a portion of the 1917 addition's footprint has been excavated. It has a concrete floor, concrete foundation walls, and a wood lathe and plaster ceiling (**Photos 24 and 25**). Piping and conduit are exposed throughout. One window is located at the north wall. A couple of wood doors and trim that may be historic were observed in this section.

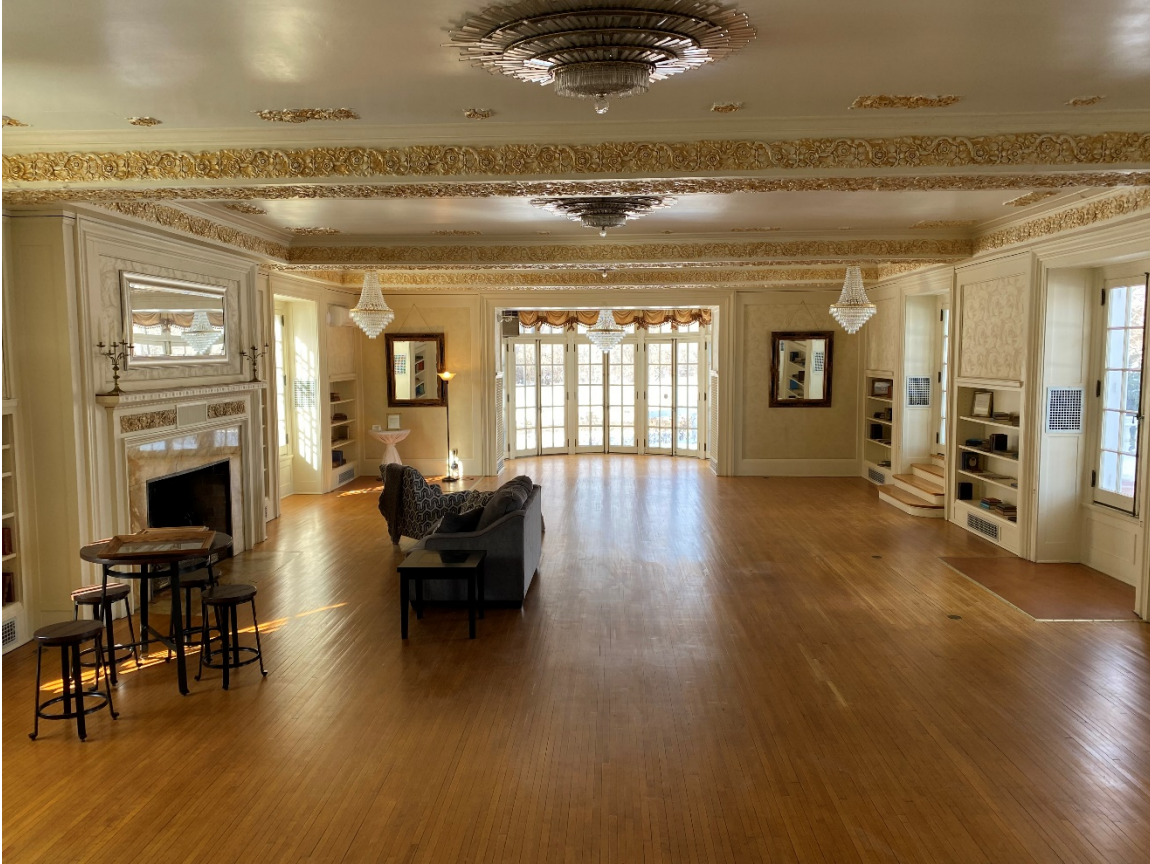
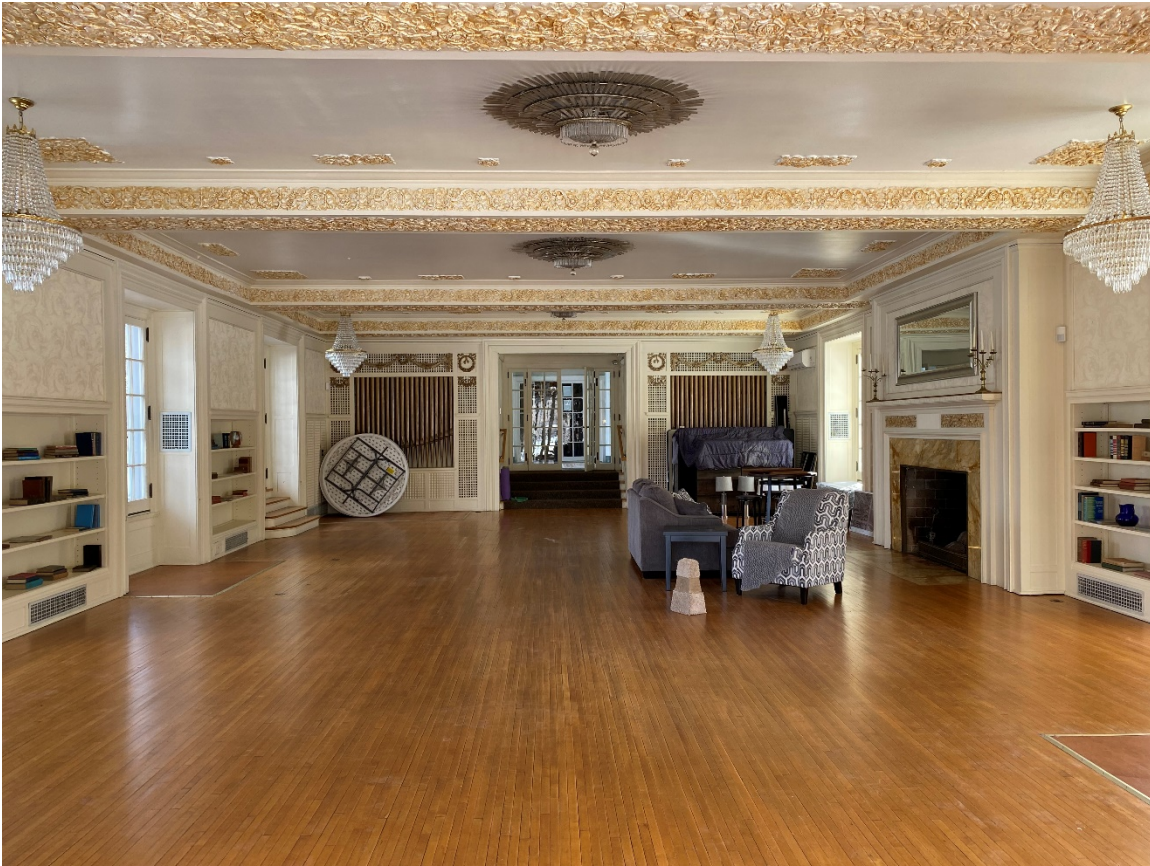
Photo 28. View of first level ballroom in Severance House (Wing A), looking north.

Photo 29. View of first level ballroom in Severance House, looking south.

Moving north from the entrance hall, a set of wood and glass doors and short flight of wood stairs leads to the sunken ballroom (**Photos 28 and 29**), which is slightly below grade. The ballroom features wood floors, a decorative plaster ceiling with moldings, plaster-covered beams, and elaborate chandeliers, and extensive wood trim and paneling. French doors on the east and west sides of the room open onto the east lawn and the rear driveway, respectively; two doors on the east side are accessed via sets of wood steps. Built-in bookshelves are also located on the east and west walls. At the north side of the ballroom, the projecting, semi-circular bay of French doors forms a small sunroom. A large fireplace with carved wood mantle and stone surround is located on the west wall. The pipes of a former organ (not extant) surrounded by decorative wood grating are located on the south wall. Along the edges of the room, there are several patches of non-original flooring.<sup>16</sup>

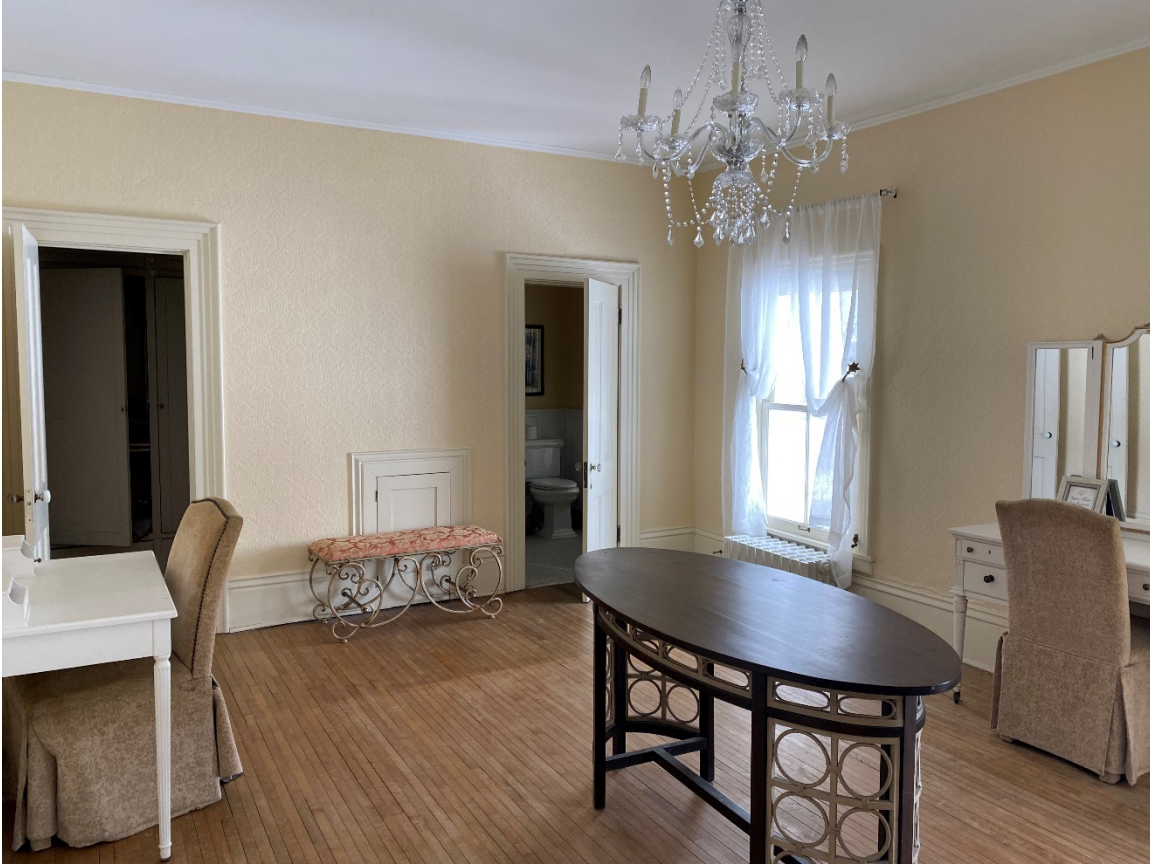
**Photo 42.** View of second-level bedroom at Severance House (Wing A), looking northeast.

Most bedrooms at the second level of Wing A have wood floors, baseboard, crown molding, and window and door trim (see for example **Photo 42**). Wood built-ins (such as cupboards and shelves – see for example **Photo 43**), wood-paneled doors, and metal radiators are located throughout. Some walls are finished with modern wall paper and/or wall coverings; some plaster walls and ceilings were also observed. Four bathrooms have hexagon floor tile and rectangular wall tile matching restrooms on the first level. Two restrooms have wood paneled wainscot instead of wall tile (see for example **Photo 44**), one has vertical wood plank wainscot and wood floors, and one has non-historic tile at the floor and walls.

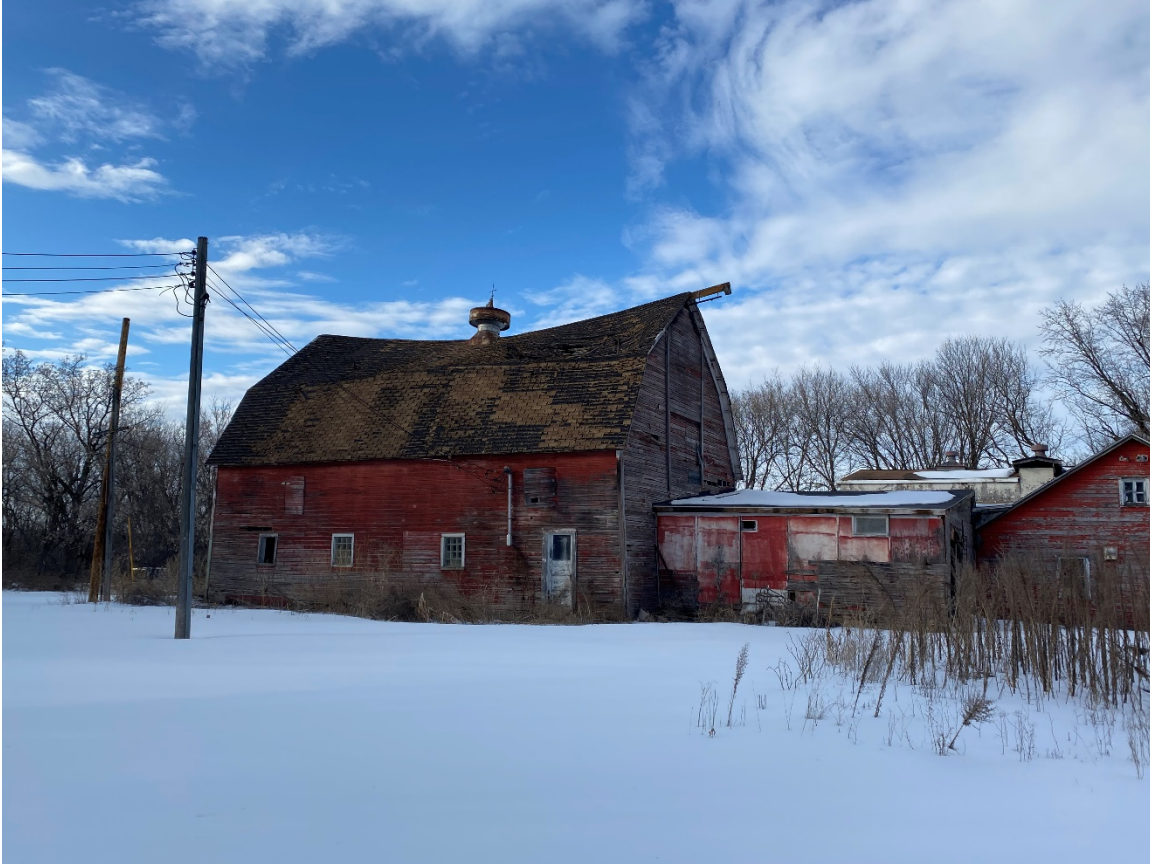
**Photo 51.** View of north and west elevations of the barn, looking southeast.

A gambrel-roofed barn is located to the northwest of the house (**Photos 51 and 52**). The barn cannot be dated with certainty; however, barns of this design were commonly constructed in Cottage Grove between 1900 and 1920, suggesting that this structure dates to the early 1900s. The only available historic photograph of this structure is undated and shows only a portion of the barn's

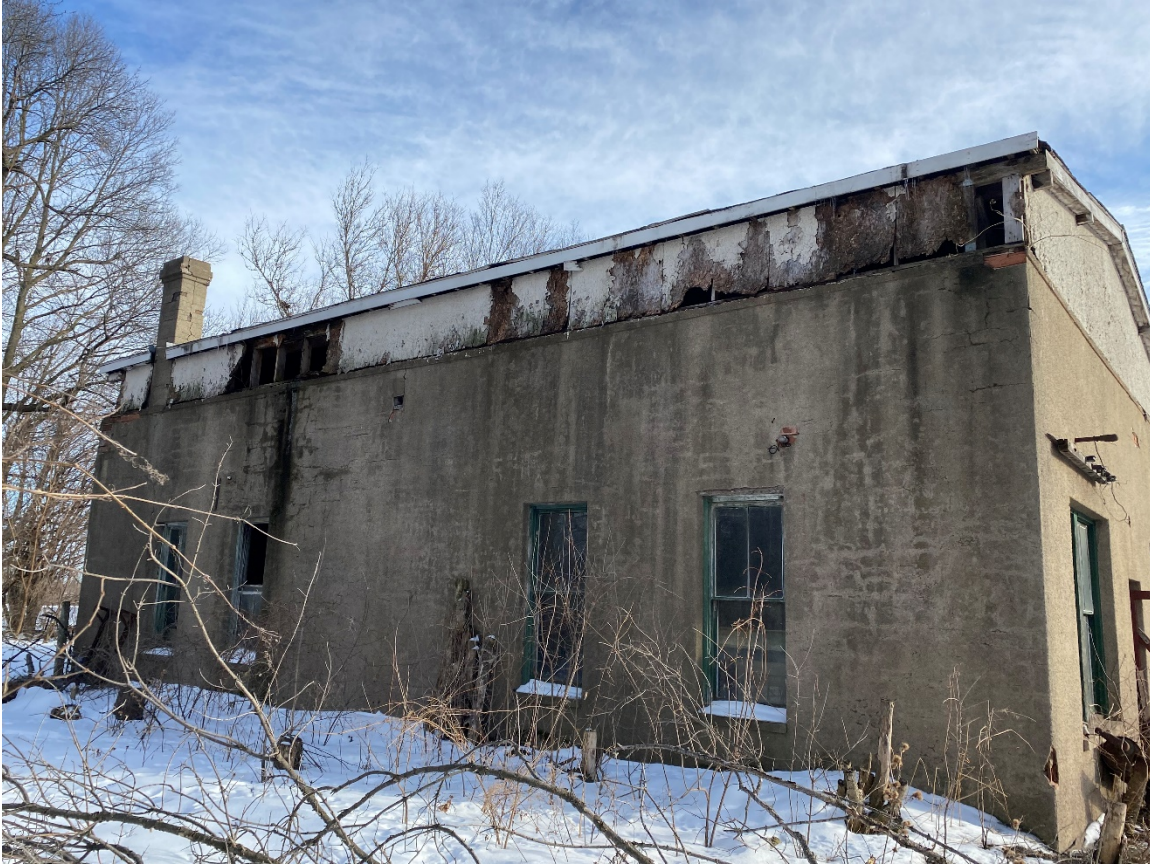
**Photo 53.** View of east elevation of garage, looking west.

The garage is a one-story, gable-roofed structure also located northwest of the house (**Photos 53 and 54**). The garage was designed by the St. Paul architectural firm of Charles Reed and Allen Stem and constructed by the contracting firm Hoy & Elzy Company in 1911.<sup>24</sup> The only available historic photograph of the property is undated, but based on the appearance and quality of the photograph, it is possible that this photo dates to the proposed period of significance (**Figure N**).

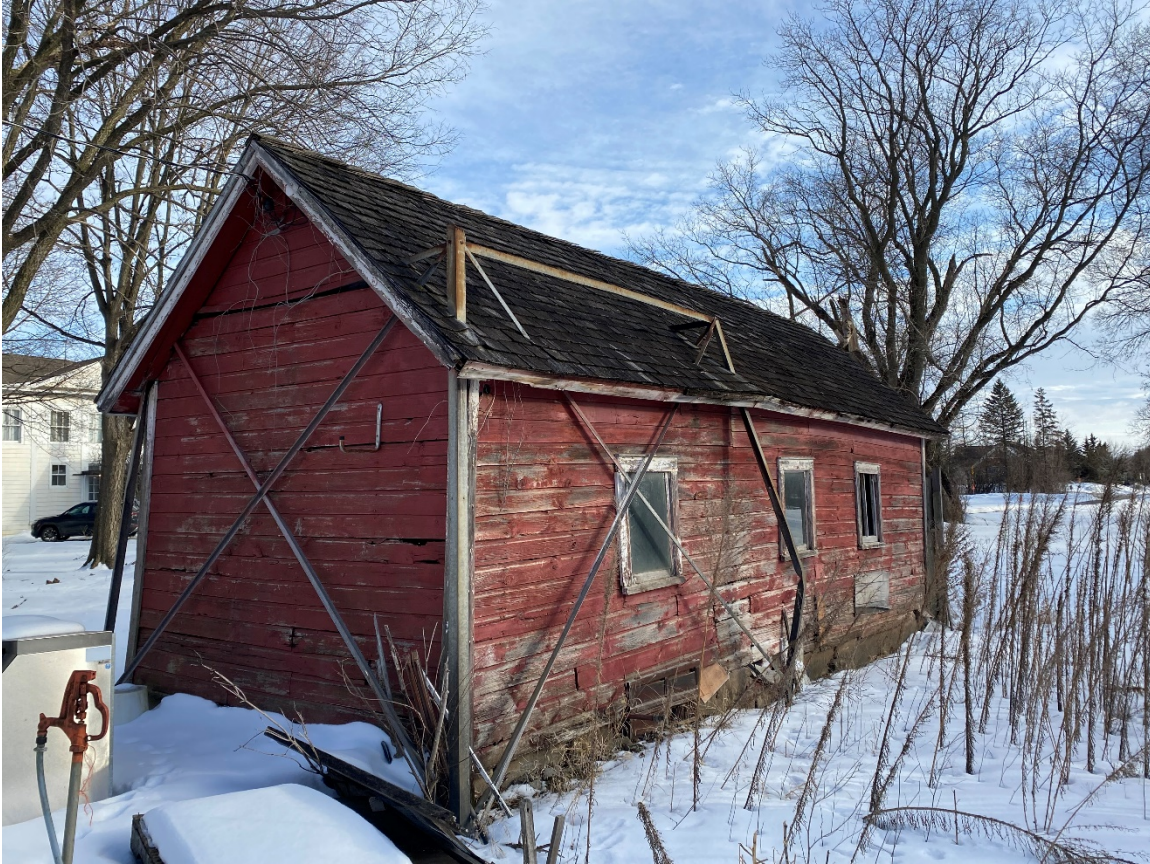
Photo 55. View of south and east elevations of upholstery shop, looking northwest.

A one-story, gable-roofed "upholstery shop" abuts the south elevation of the garage (**Photo 55**). The only available historic photograph of the property is undated and only shows the west edge of the building. Based on the appearance and quality of the photograph, it is possible that the photo,

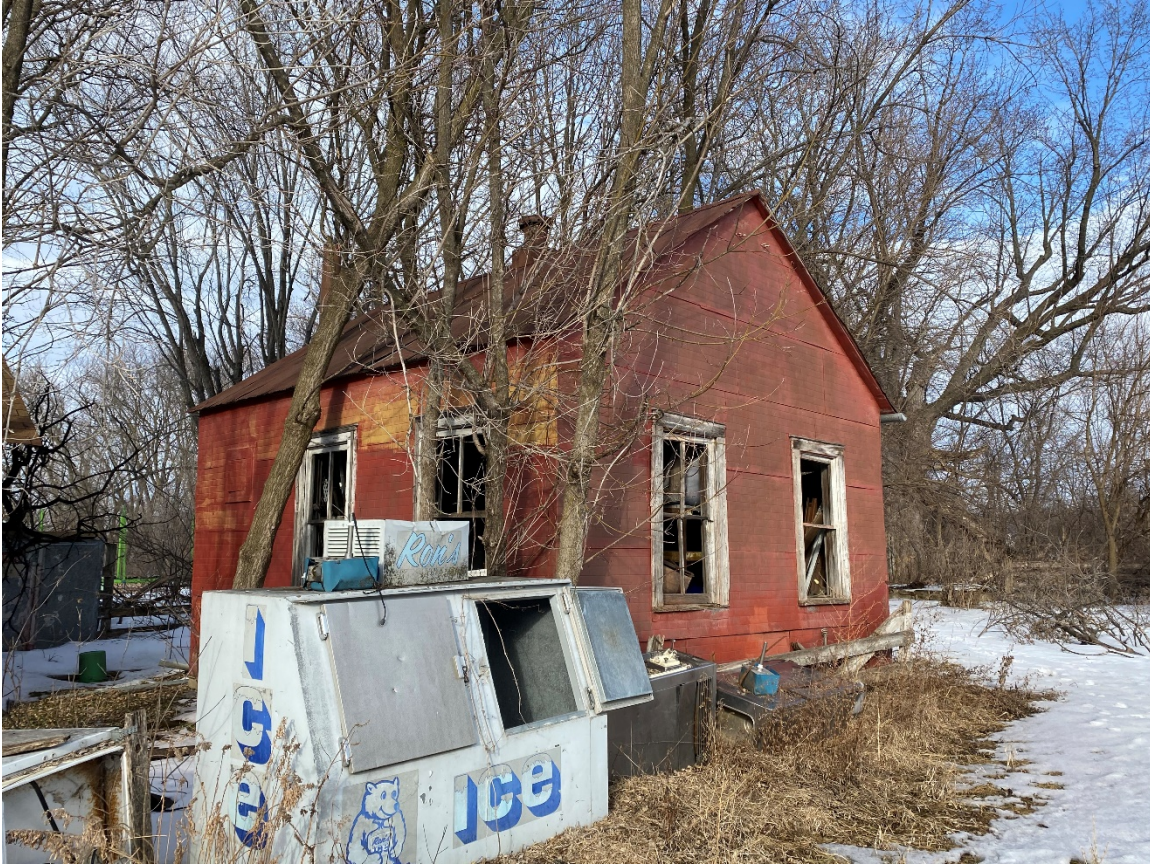
Photo 56. View of north and west elevations of chicken coop, looking southeast.

A gable-roofed, one-story chicken coop is located south of the upholstery shop (**Photo 56**). The structure is not visible in any historic photographs and cannot be dated with certainty. Based on the structure's design and condition of its materials, it may have been constructed during the period of significance, but this cannot be confirmed.

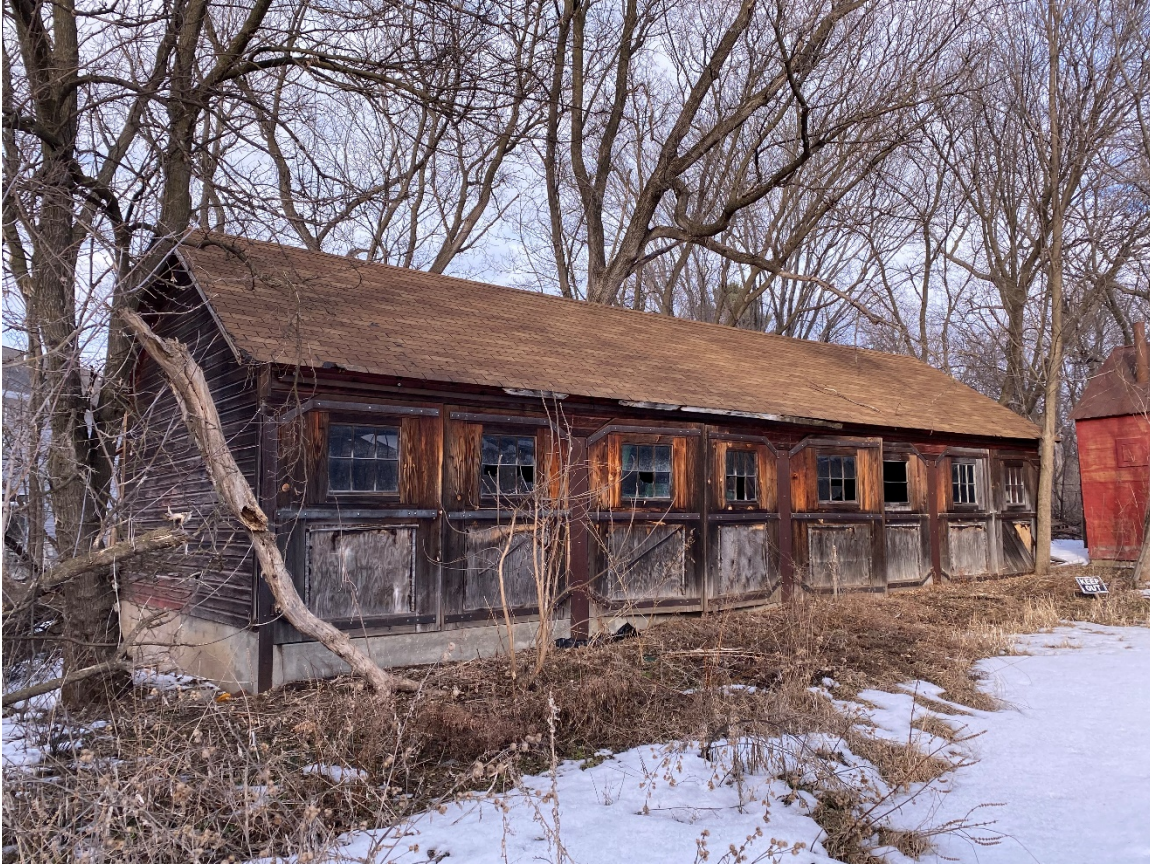
Photo 57. View of west and south elevations of shed #1, looking northeast.

A small, one-story, gable-roofed shed is located to the northwest of the garage (**Photo 57**). A structure of a similar shape appears in this approximate location in a 1945 aerial photograph of the property, suggesting that the existing shed was constructed by this date.<sup>27</sup> Based on the structure's design and condition of its materials, it may have been constructed during the period of significance, but this cannot be confirmed.

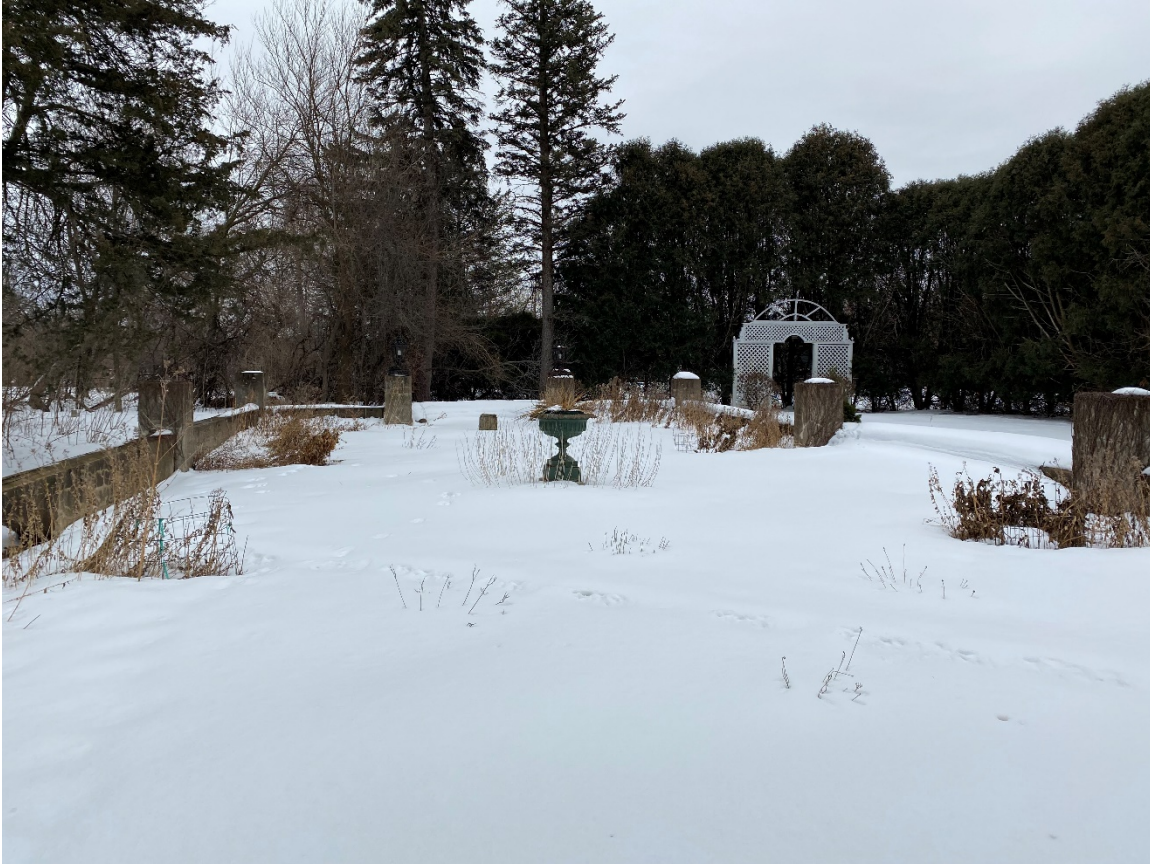
Photo 61. View of trellis, looking southeast.

A wood trellis is located adjacent to the garden (**Photo 61**). Its design does not match the wood trellises at the garden wall visible in historic photographs. Based on its materials and design, the trellis appears to have been constructed after the proposed period of significance and is therefore recommended as a non-contributing resource.

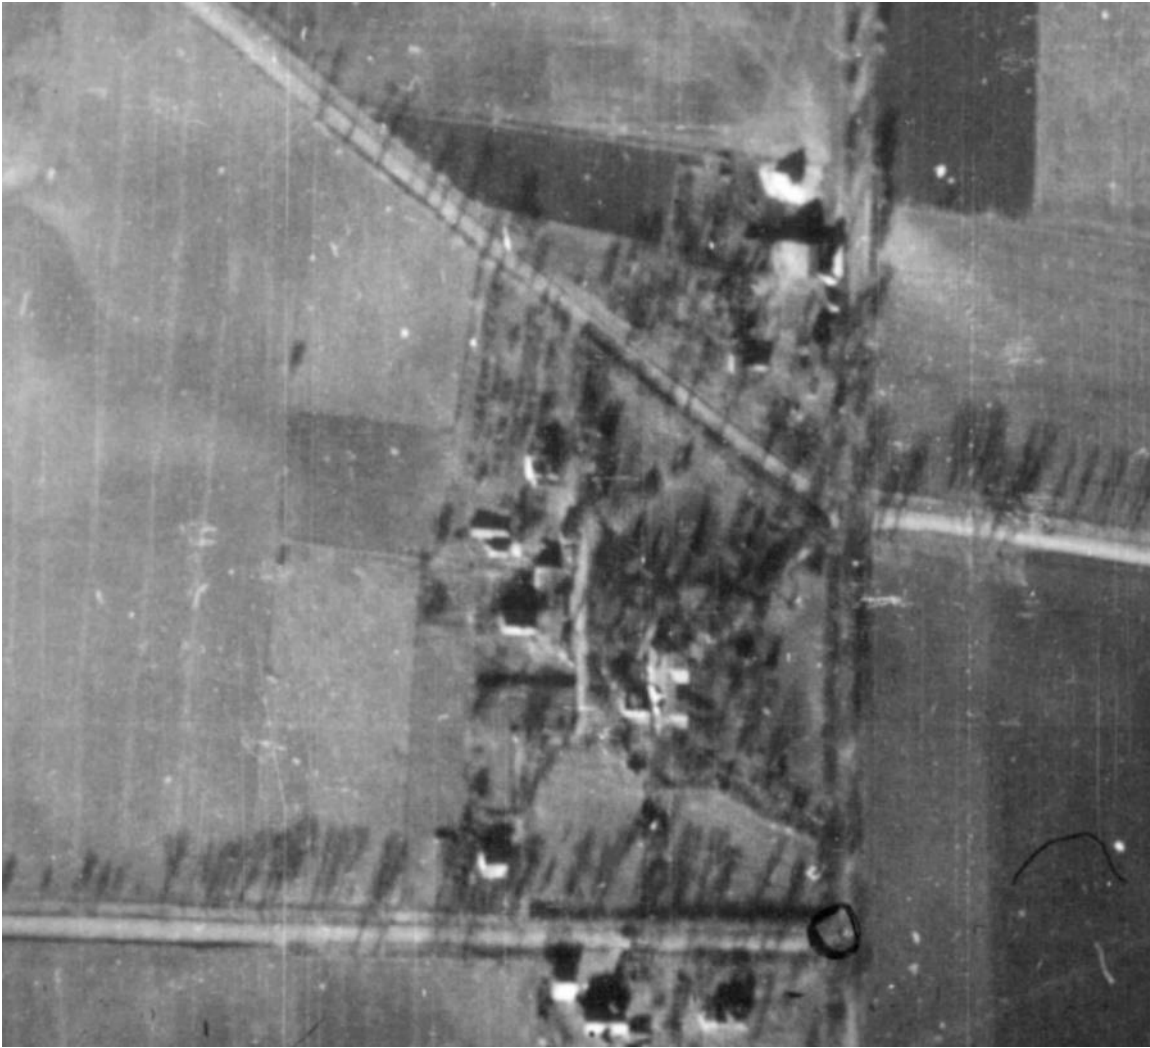
**Figure B.** Aerial photograph of Cedarhurst, 1936. Photograph courtesy of the John. R. Borchert Map Library Minnesota Historical Aerial Photographs Online, <https://apps.lib.umn.edu/mhapo/>. North is up.

Other articles written during the proposed period of significance describe the site as having "tall and magnificent ancient trees" and "spacious lawns [and] lovely gardens." One 1925 article noted that the house was "set in the center of a grove of giant cedars." Based on these descriptions and historical photographs (**Figures E – J**), it appears that the site historically had a mixture of open lawn and mature trees, including cedars like those currently located to the south of the house. The earliest available aerial photograph from 1936 shows a vegetative border surrounding the site with trees and vegetation surrounding the house and lining the drives and walkways from Keats Avenue South and Military Road towards the buildings at the center of the site. Areas of open lawn were located between the vegetation-lined walkways (**Figures B and C**).<sup>7</sup>
