**COTTAGE GROVE ADVISORY COMMITTEE  
ON HISTORIC PRESERVATION**

**MINUTES**  
**CITY OF COTTAGE GROVE**  
**ADVISORY COMMITTEE ON HISTORIC PRESERVATION**  
**June 10, 2025**

***Cardenio Severance (Cedarhurst) Mansion CUP Proposal by Bellagala***

Cordenio Severance House Development Diagram

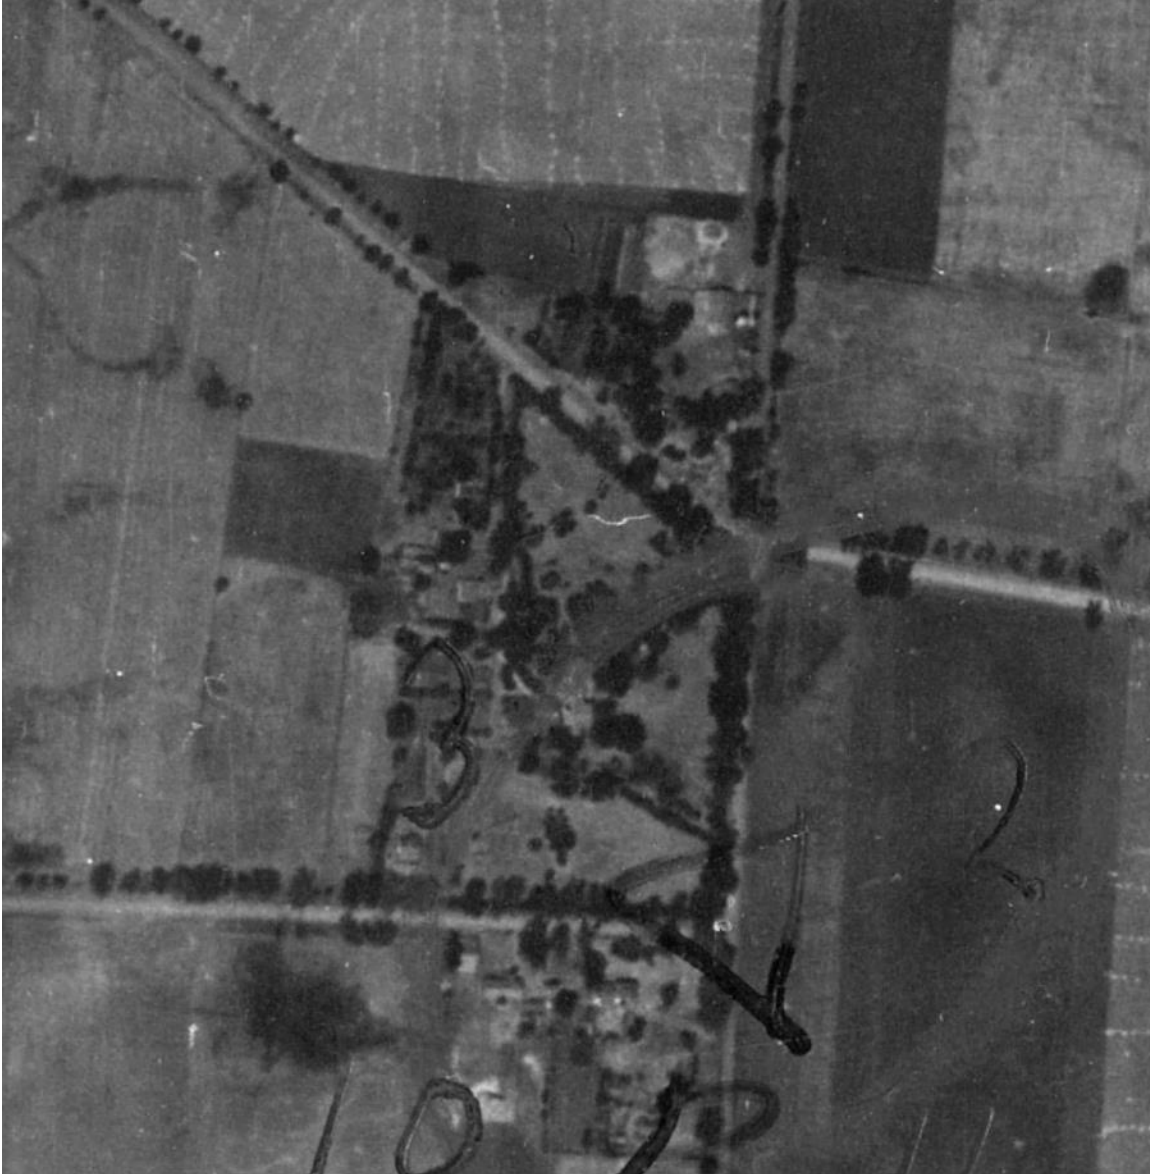
**Figure C.** Aerial photograph of Cedarhurst, 1936. Photograph courtesy of the John R. Borchert Map Library Minnesota Historical Aerial Photographs Online, <https://apps.lib.umn.edu/mhapo/>. North is up.

Other articles written during the proposed period of significance describe the site as having "tall and magnificent ancient trees" and "spacious lawns [and] lovely gardens." One 1925 article noted that the house was "set in the center of a grove of giant cedars." Based on these descriptions and historical photographs (**Figures E – J**), it appears that the site historically had a mixture of open lawn and mature trees, including cedars like those currently located to the south of the house. The earliest available aerial photograph from 1936 shows a vegetative border surrounding the site with trees and vegetation surrounding the house and lining the drives and walkways from Keats Avenue South and Military Road towards the buildings at the center of the site. Areas of open lawn were located between the vegetation-lined walkways (**Figures B and C**).<sup>7</sup>

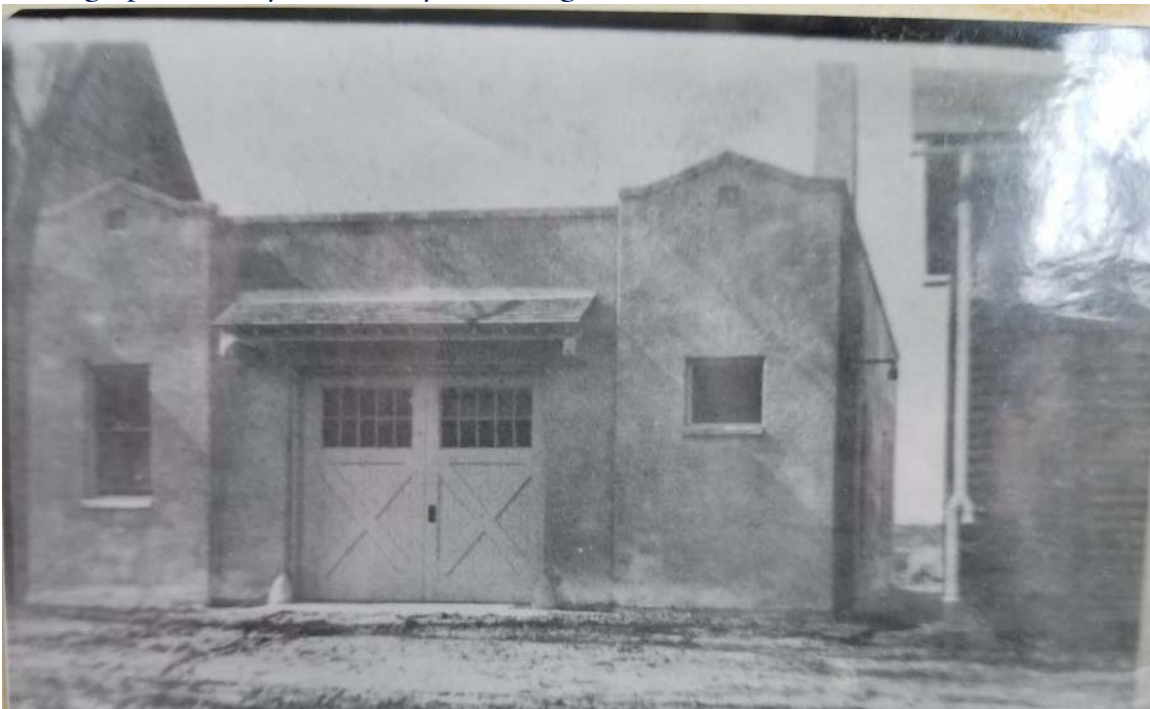
**Figure M.** View of east elevation of barn, looking northwest, likely 1925 or earlier. Photograph courtesy of the City of Cottage Grove.

A gambrel-roofed barn is located to the northwest of the house (**Photos 51 and 52**). The barn cannot be dated with certainty; however, barns of this design were commonly constructed in Cottage Grove between 1900 and 1920, suggesting that this structure dates to the early 1900s. The only available historic photograph of this structure is undated and shows only a portion of the barn's

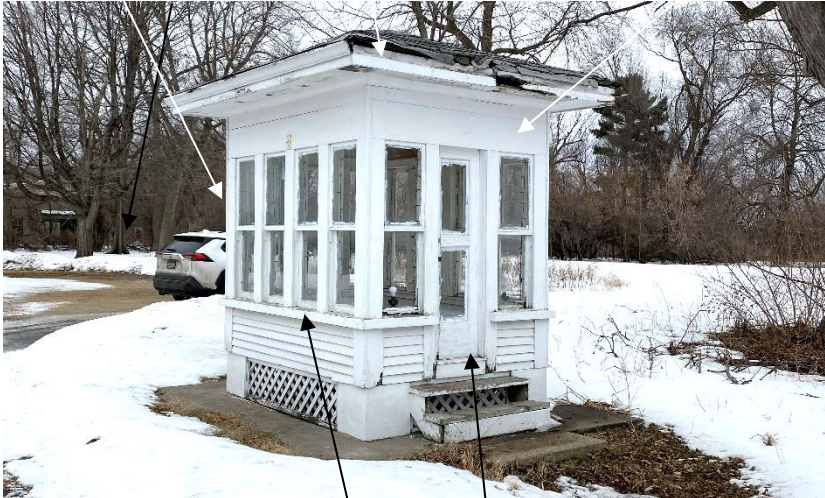
| Key Historic Features | | Orientation |
|---|--|---|
| <p>Square plan      Hipped roof with overhanging eaves      Wood siding</p> <p>Wood windows      Wood door</p> | | <p>The Valet Shelter is located on the northeast side of the Cordenio Severance House (see Fig. 2). This structure was formerly a cupola on the roof of the Cordenio Severance House.</p> |
| <ul style="list-style-type: none"> <li>• Rectangular-shaped structure</li> <li>• Hipped roof with overhanging eaves</li> </ul> | | <ul style="list-style-type: none"> <li>• Concrete slab</li> </ul> |

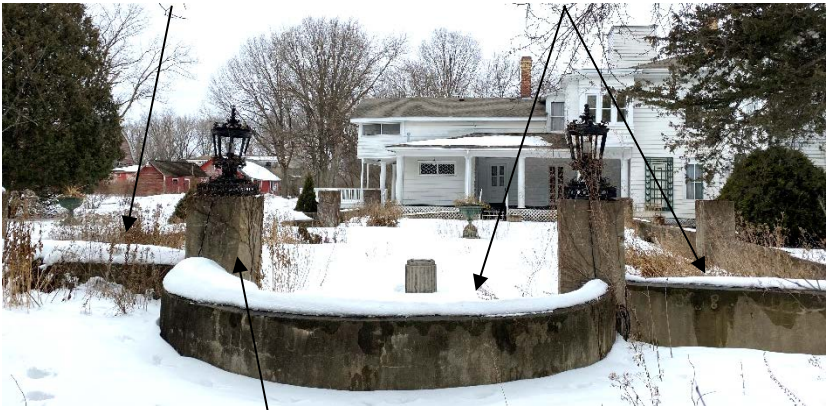
| Key Historic Features | | Orientation |
|---|--|---|
| <p>Partial-height concrete walls</p> <p>Straight and curved walls</p> <p>Square posts</p> | | The Garden Wall is located on the southwest side of the Cordenio Severance House (see Fig. 2) |
| <ul style="list-style-type: none"> <li>• Straight and curved walls</li> <li>• Partial-height concrete walls with square posts</li> </ul> | | <ul style="list-style-type: none"> <li>• Concrete slab</li> </ul> |

| Key Historic Features | | Orientation |
|---|--|---|
| <ul style="list-style-type: none"> <li>• New balustrade matching or similar to the historic can be constructed if desired</li> <li>• New wood trellises matching or similar to the historic can be constructed at historic locations on the west and south sides if desired</li> <li>• Light fixtures can remain, be relocated, or be salvaged on site</li> </ul> | | <ul style="list-style-type: none"> <li>• Existing key historic features (all)</li> <li>• Straight and curved wall shapes</li> <li>• Height of posts</li> <li>• Unpainted concrete should not be painted</li> </ul> |
