**Title** Workshop – Cordenio Severance House (Cedarhurst) Proposed Event Center

**Staff Recommendation** Receive an overview of the proposed rehabilitation of the building and site located at 6940 Keats Avenue (Cedarhurst) for use as an event center.

# CEDARHURST MANSION REHABILITATION

Historical Site Design Guidelines  
Severance, Cordenio House [Cedarhurst]  
6940 Keats Avenue South  
Cottage Grove, Minnesota 55016

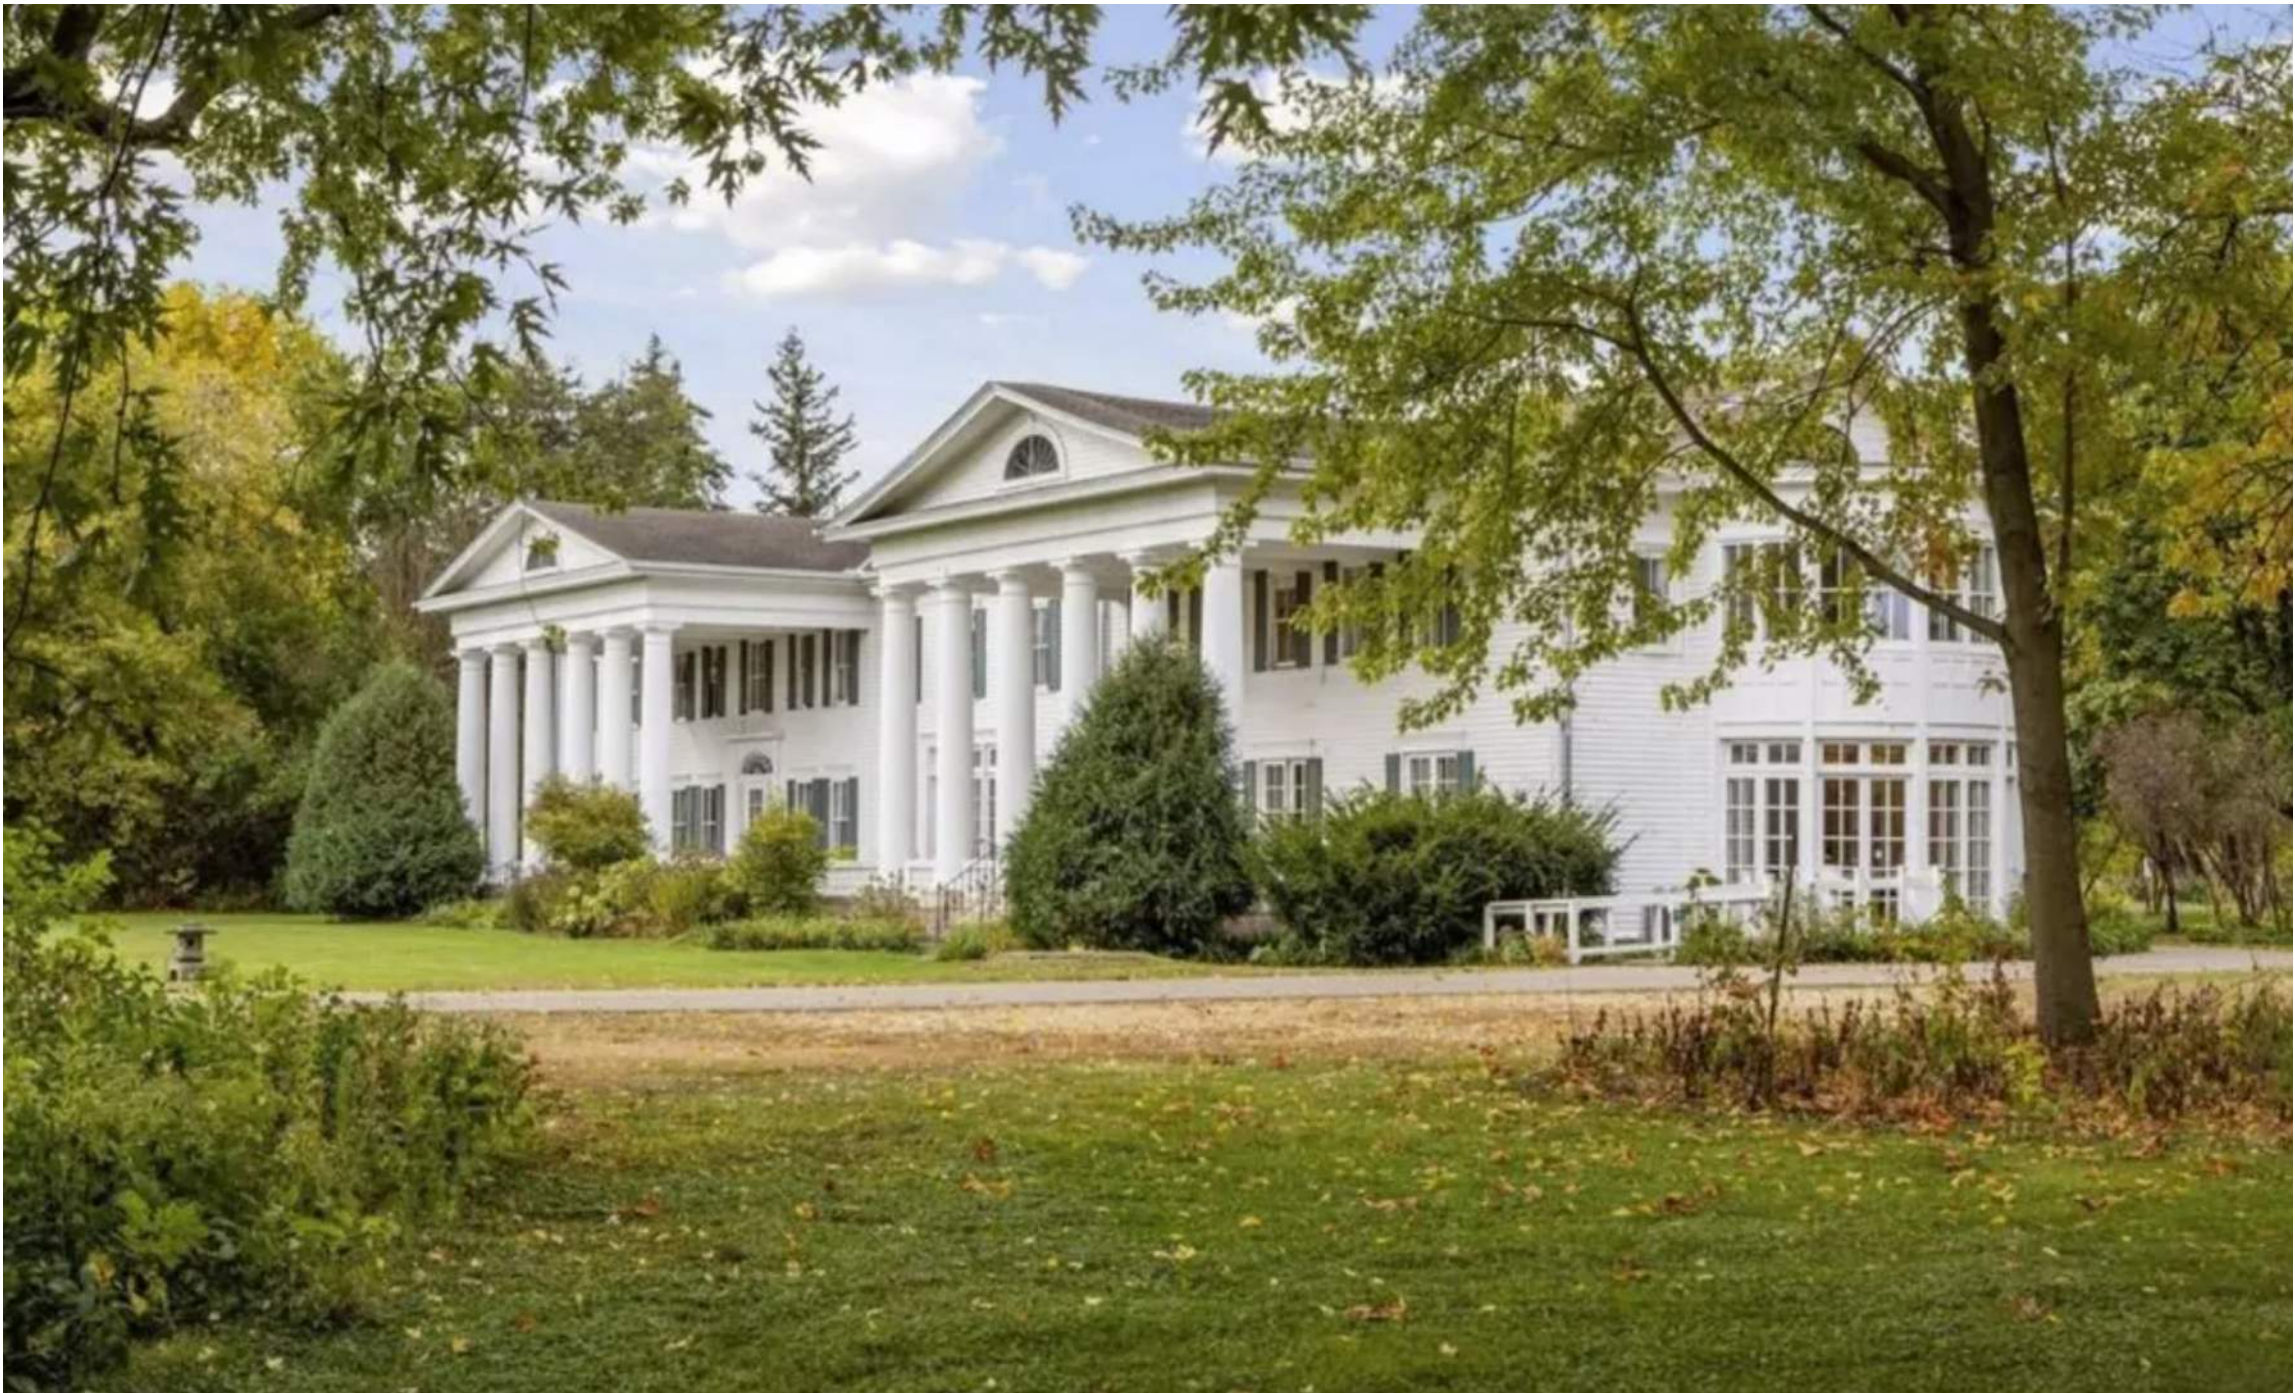
PRIMARY ELEVATION

THE HOUSE’S **EAST-FACING PRIMARY ELEVATION** FEATURES A TWO-STORY DORIC HEXASTYLE PORTICO WITH FANLIGHT PEDIMENT AND SYMMETRICAL FENESTRATION.

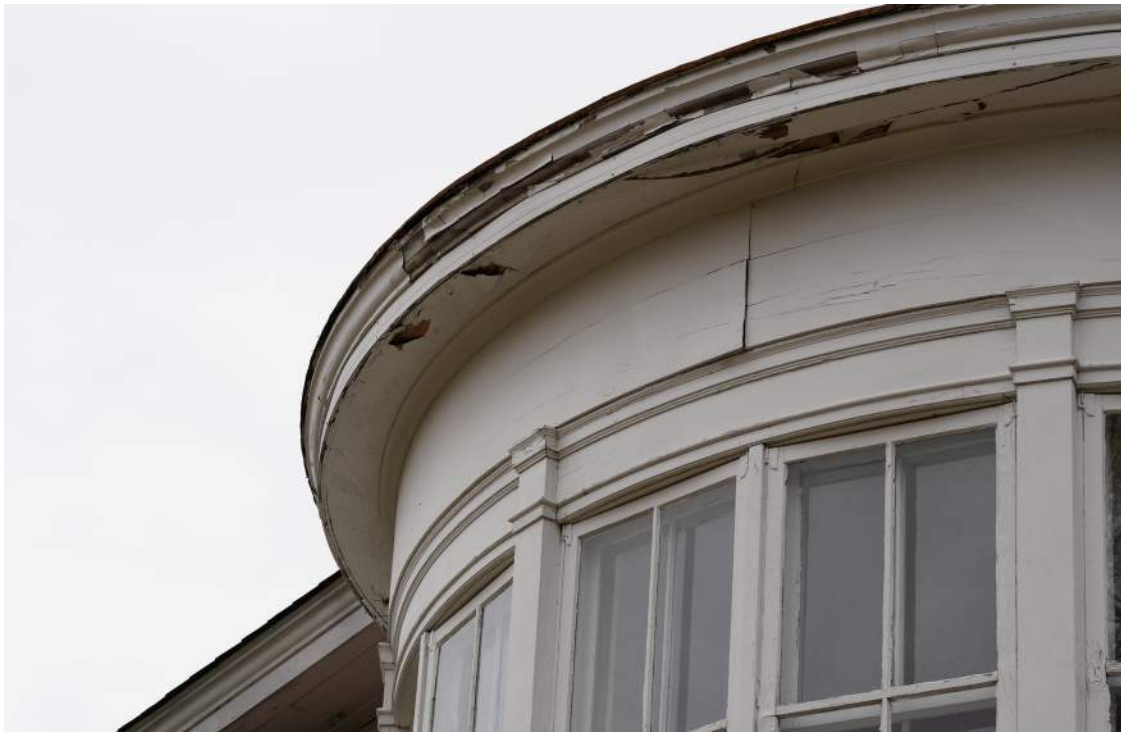
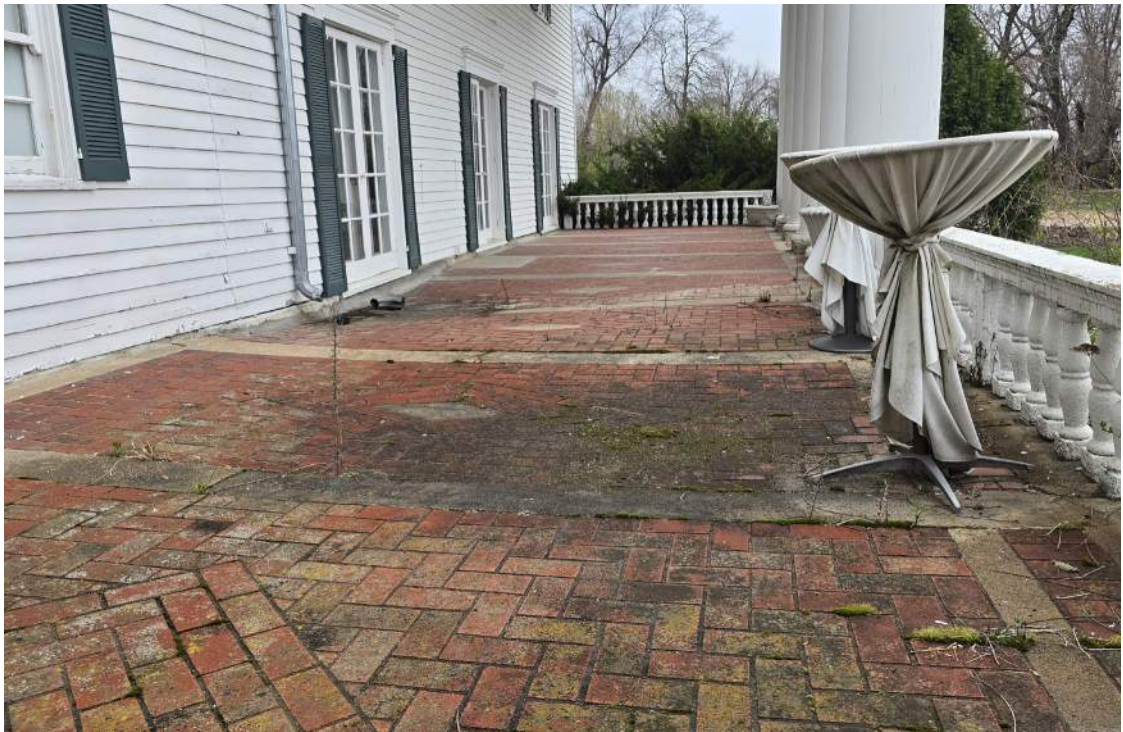
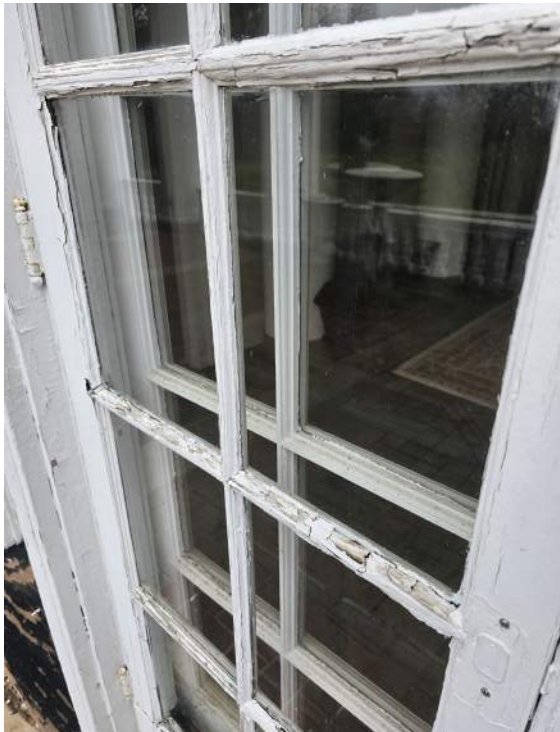
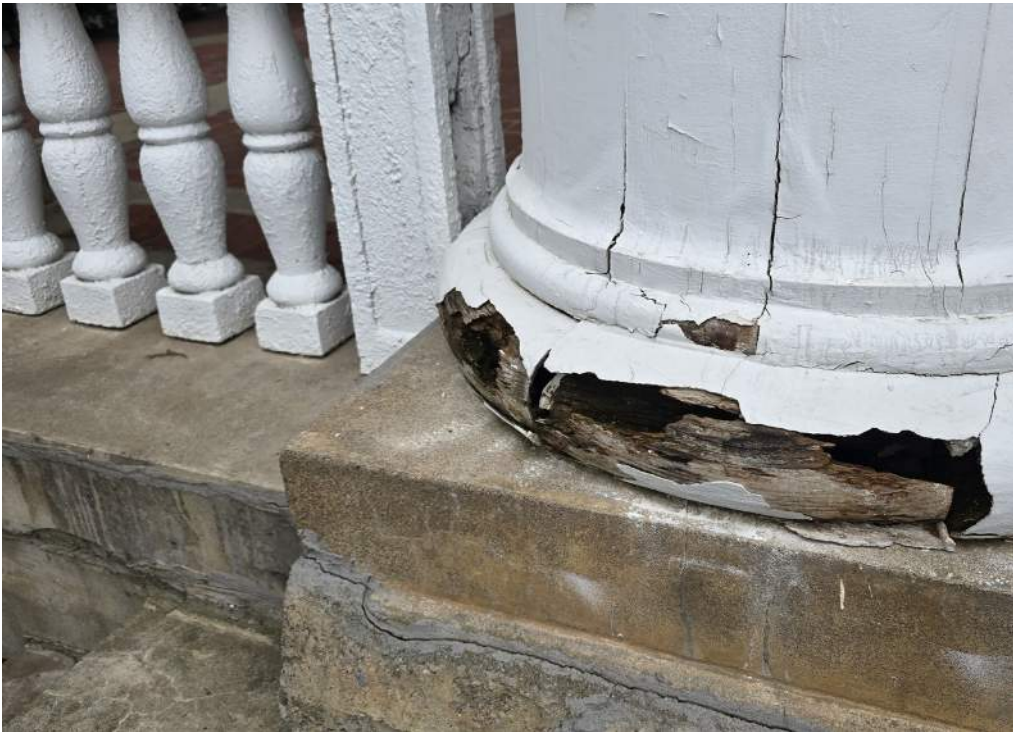
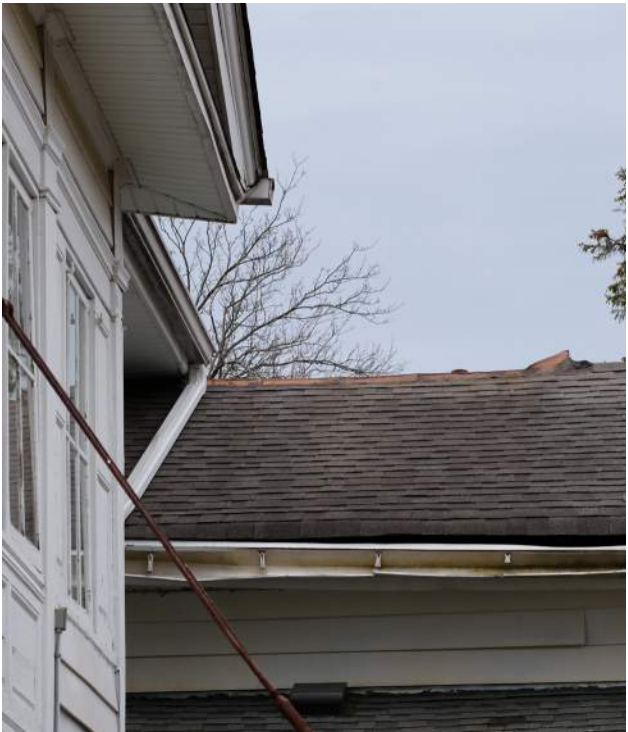
EXTERIOR PHOTOS - APRIL 2025

THE **EAST PORCH WILL BE REHABILITATED** TO RESTORE HISTORIC FEATURES, ADDRESSING **DRAINAGE ISSUES** DUE TO MID 20TH CENTURY ALTERATION THAT DIRECTS WATER TOWARD THE BUILDING.

LIMIT ROOF REPAIRS TO LOCALIZED **IN-KIND REPLACEMENT OF DAMAGED ASPHALT SHINGLES**. REPAIR/REPLACE DAMAGED GUTTERS AND DOWNSPOUTS AS NEEDED.

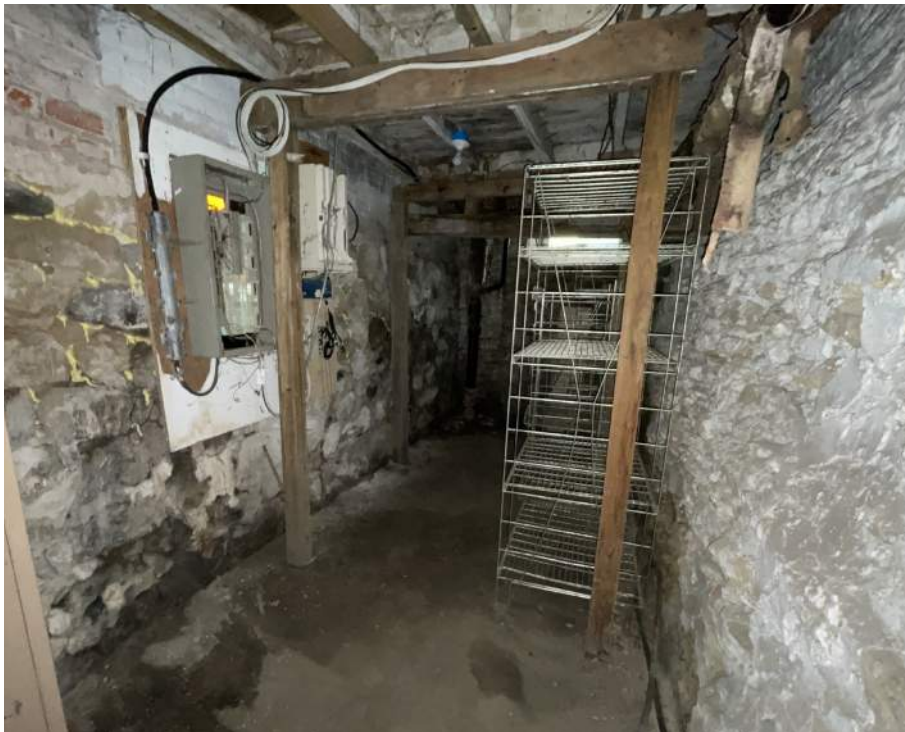
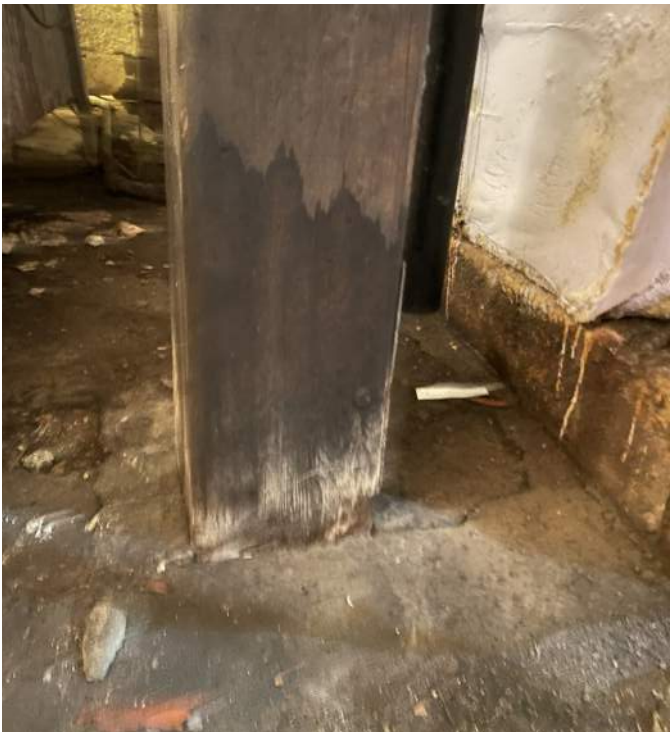
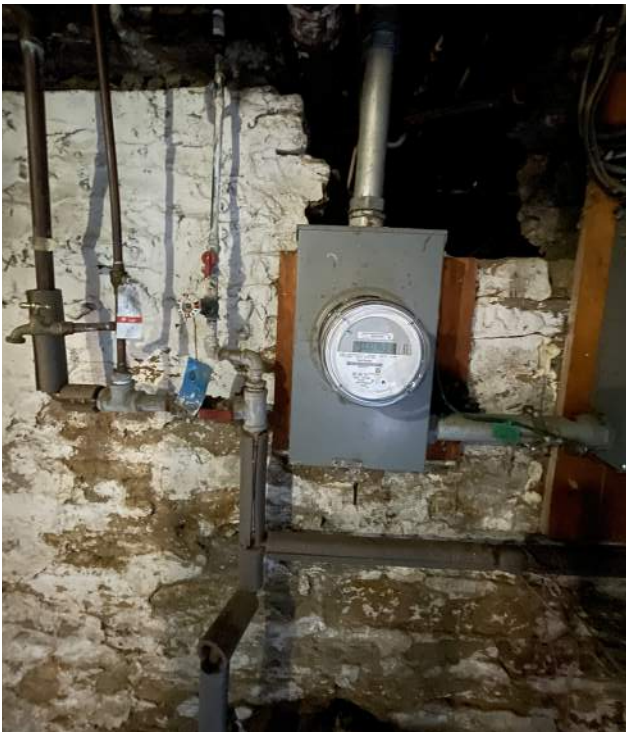
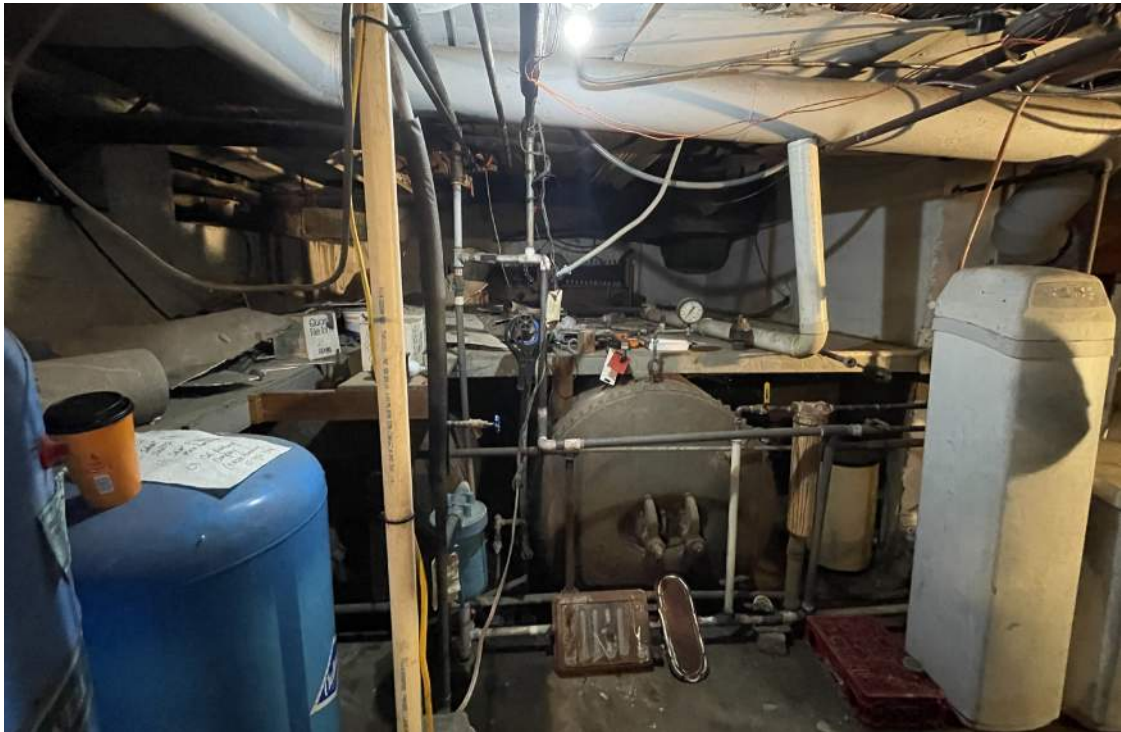
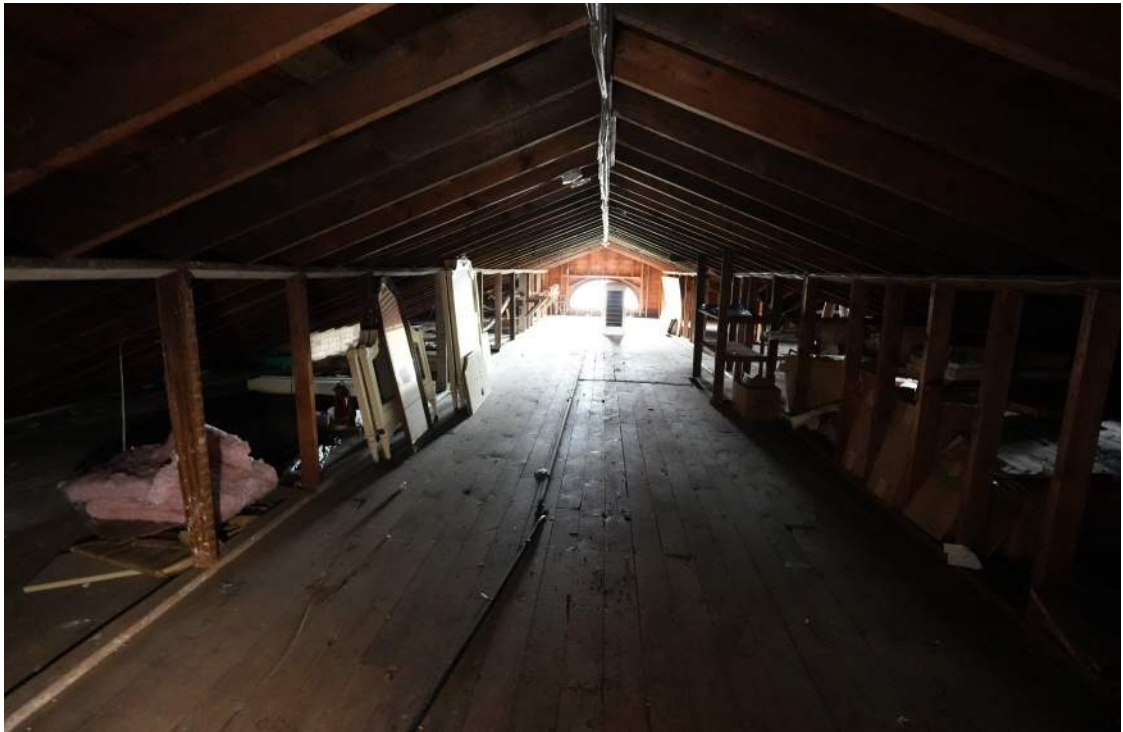
INTERIOR PHOTOS - APRIL 2025

**REPLACE OUTDATED ELECTRICAL PANELS AND WIRING** TO MEET CURRENT CAPACITY AND SAFETY CODES.

A **NEW BUILDING-WIDE SPRINKLER SYSTEM** WILL BE INSTALLED TO MEET CURRENT **FIRE AND LIFE SAFETY** CODE REQUIREMENTS.

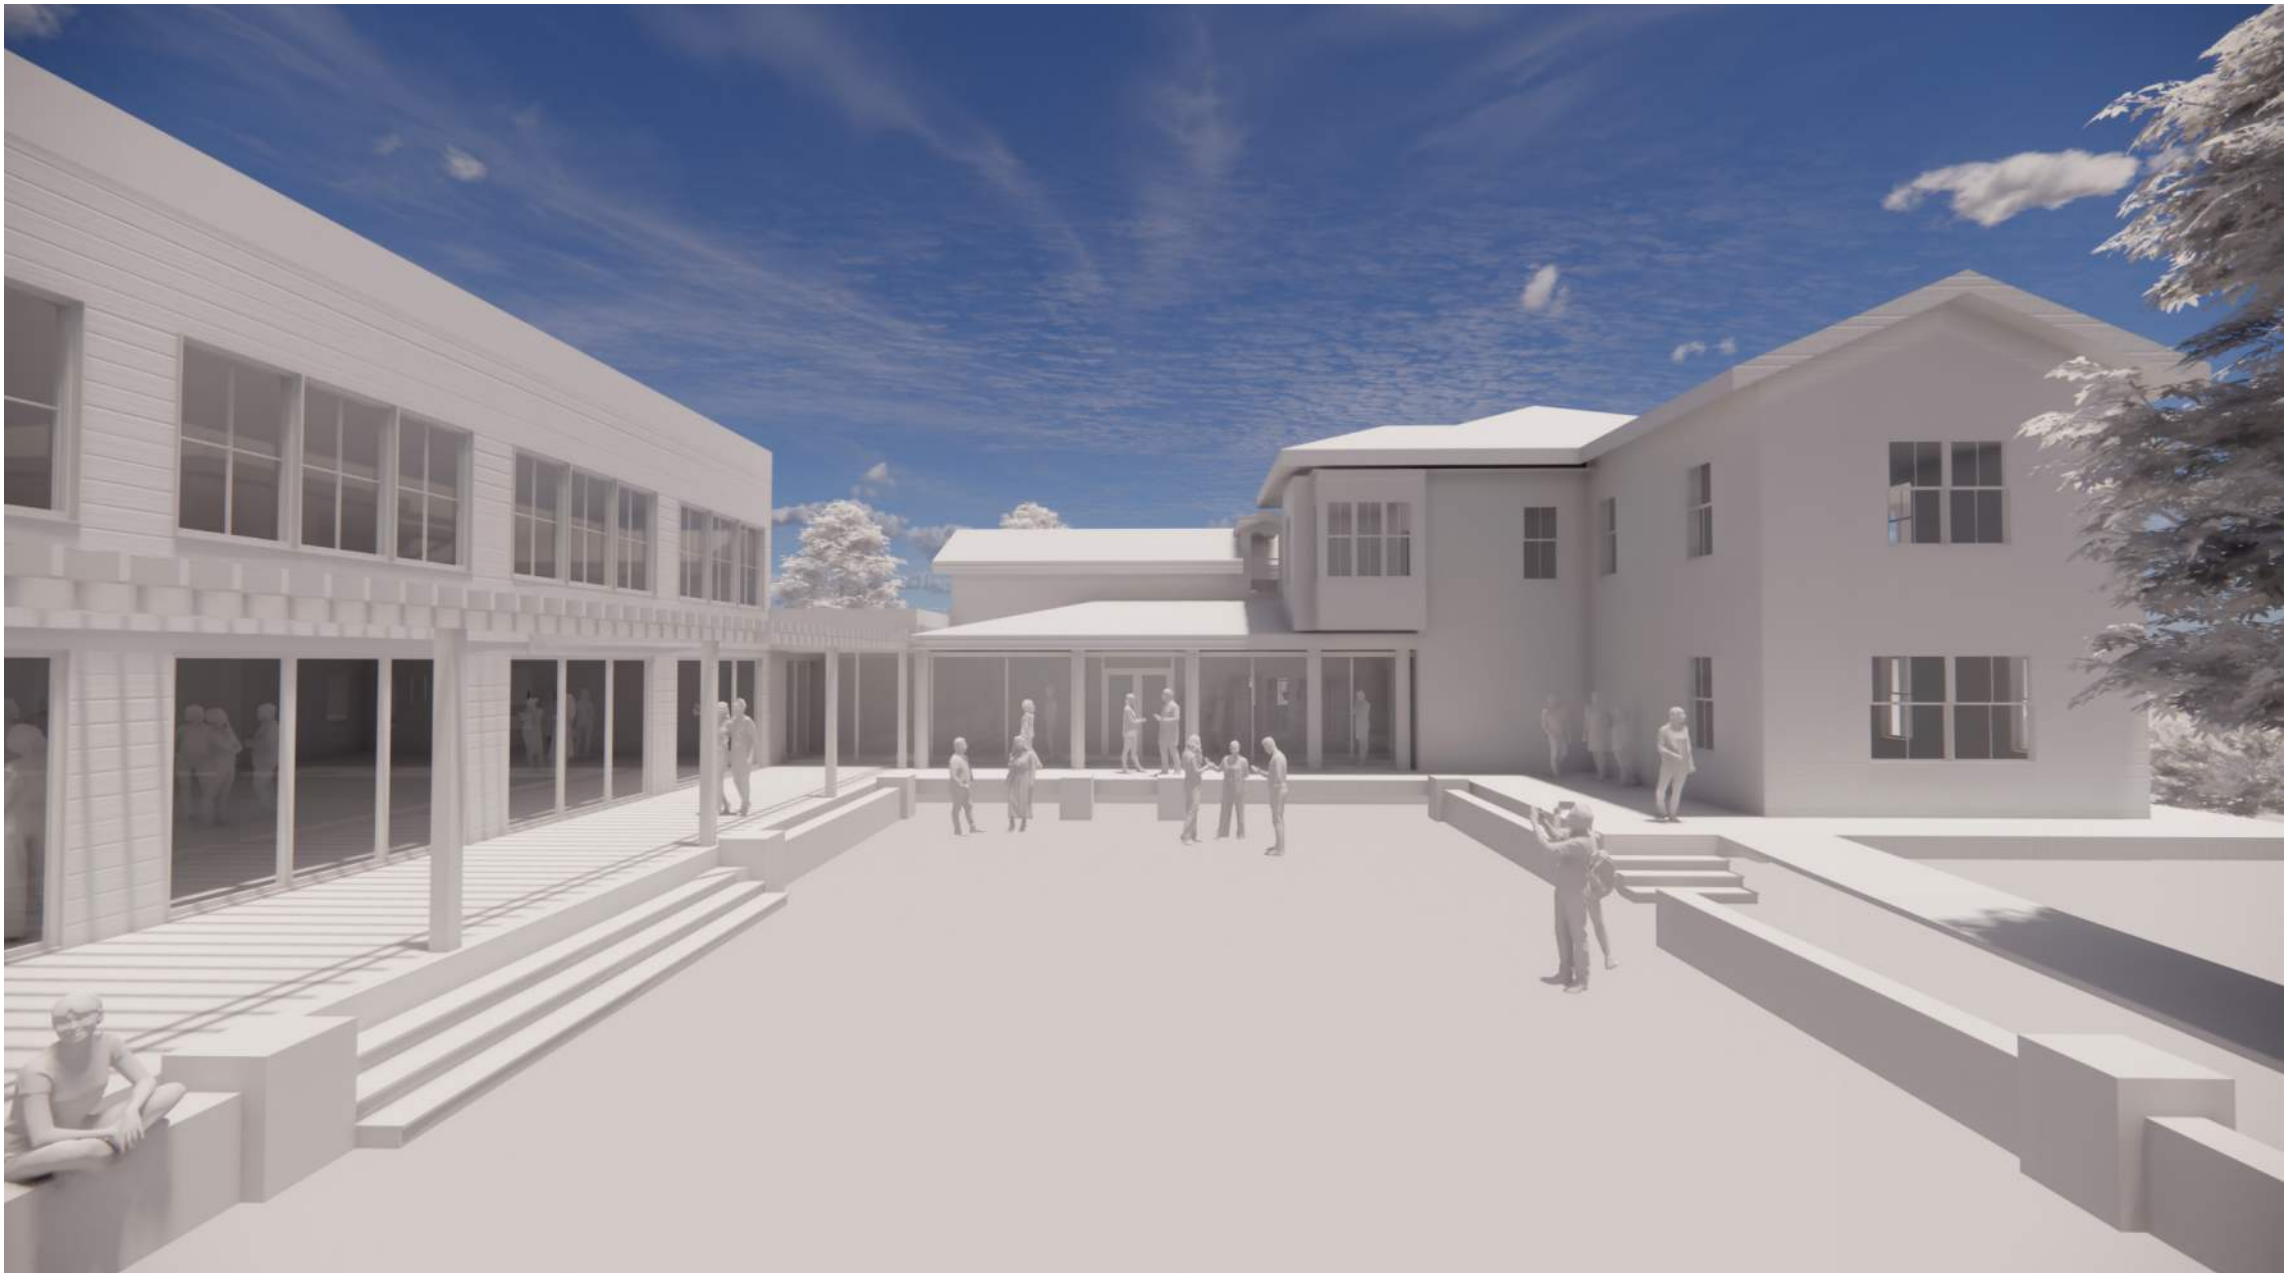
ADDITION VIEW FROM ROSE GARDEN

THE ADDITION WILL **LIGHTLY CONNECT** AT THE WEST FACADE, ADJACENT TO THE LOCATION OF THE EXISTING **NON-HISTORIC KITCHEN.**

THIS WORK **COMPLIES WITH THE SECRETARY OF THE INTERIOR'S STANDARDS FOR REHABILITATION**, PARTICULARLY THOSE ADDRESSING NEW ADDITIONS, AND HAS BEEN DESIGNED TO ENSURE **THE NEW CONSTRUCTION IS REVERSIBLE AND IS IN DEREERENCE** TO THE MANSION'S HISTORIC CHARACTER AND SIGNIFICANCE.

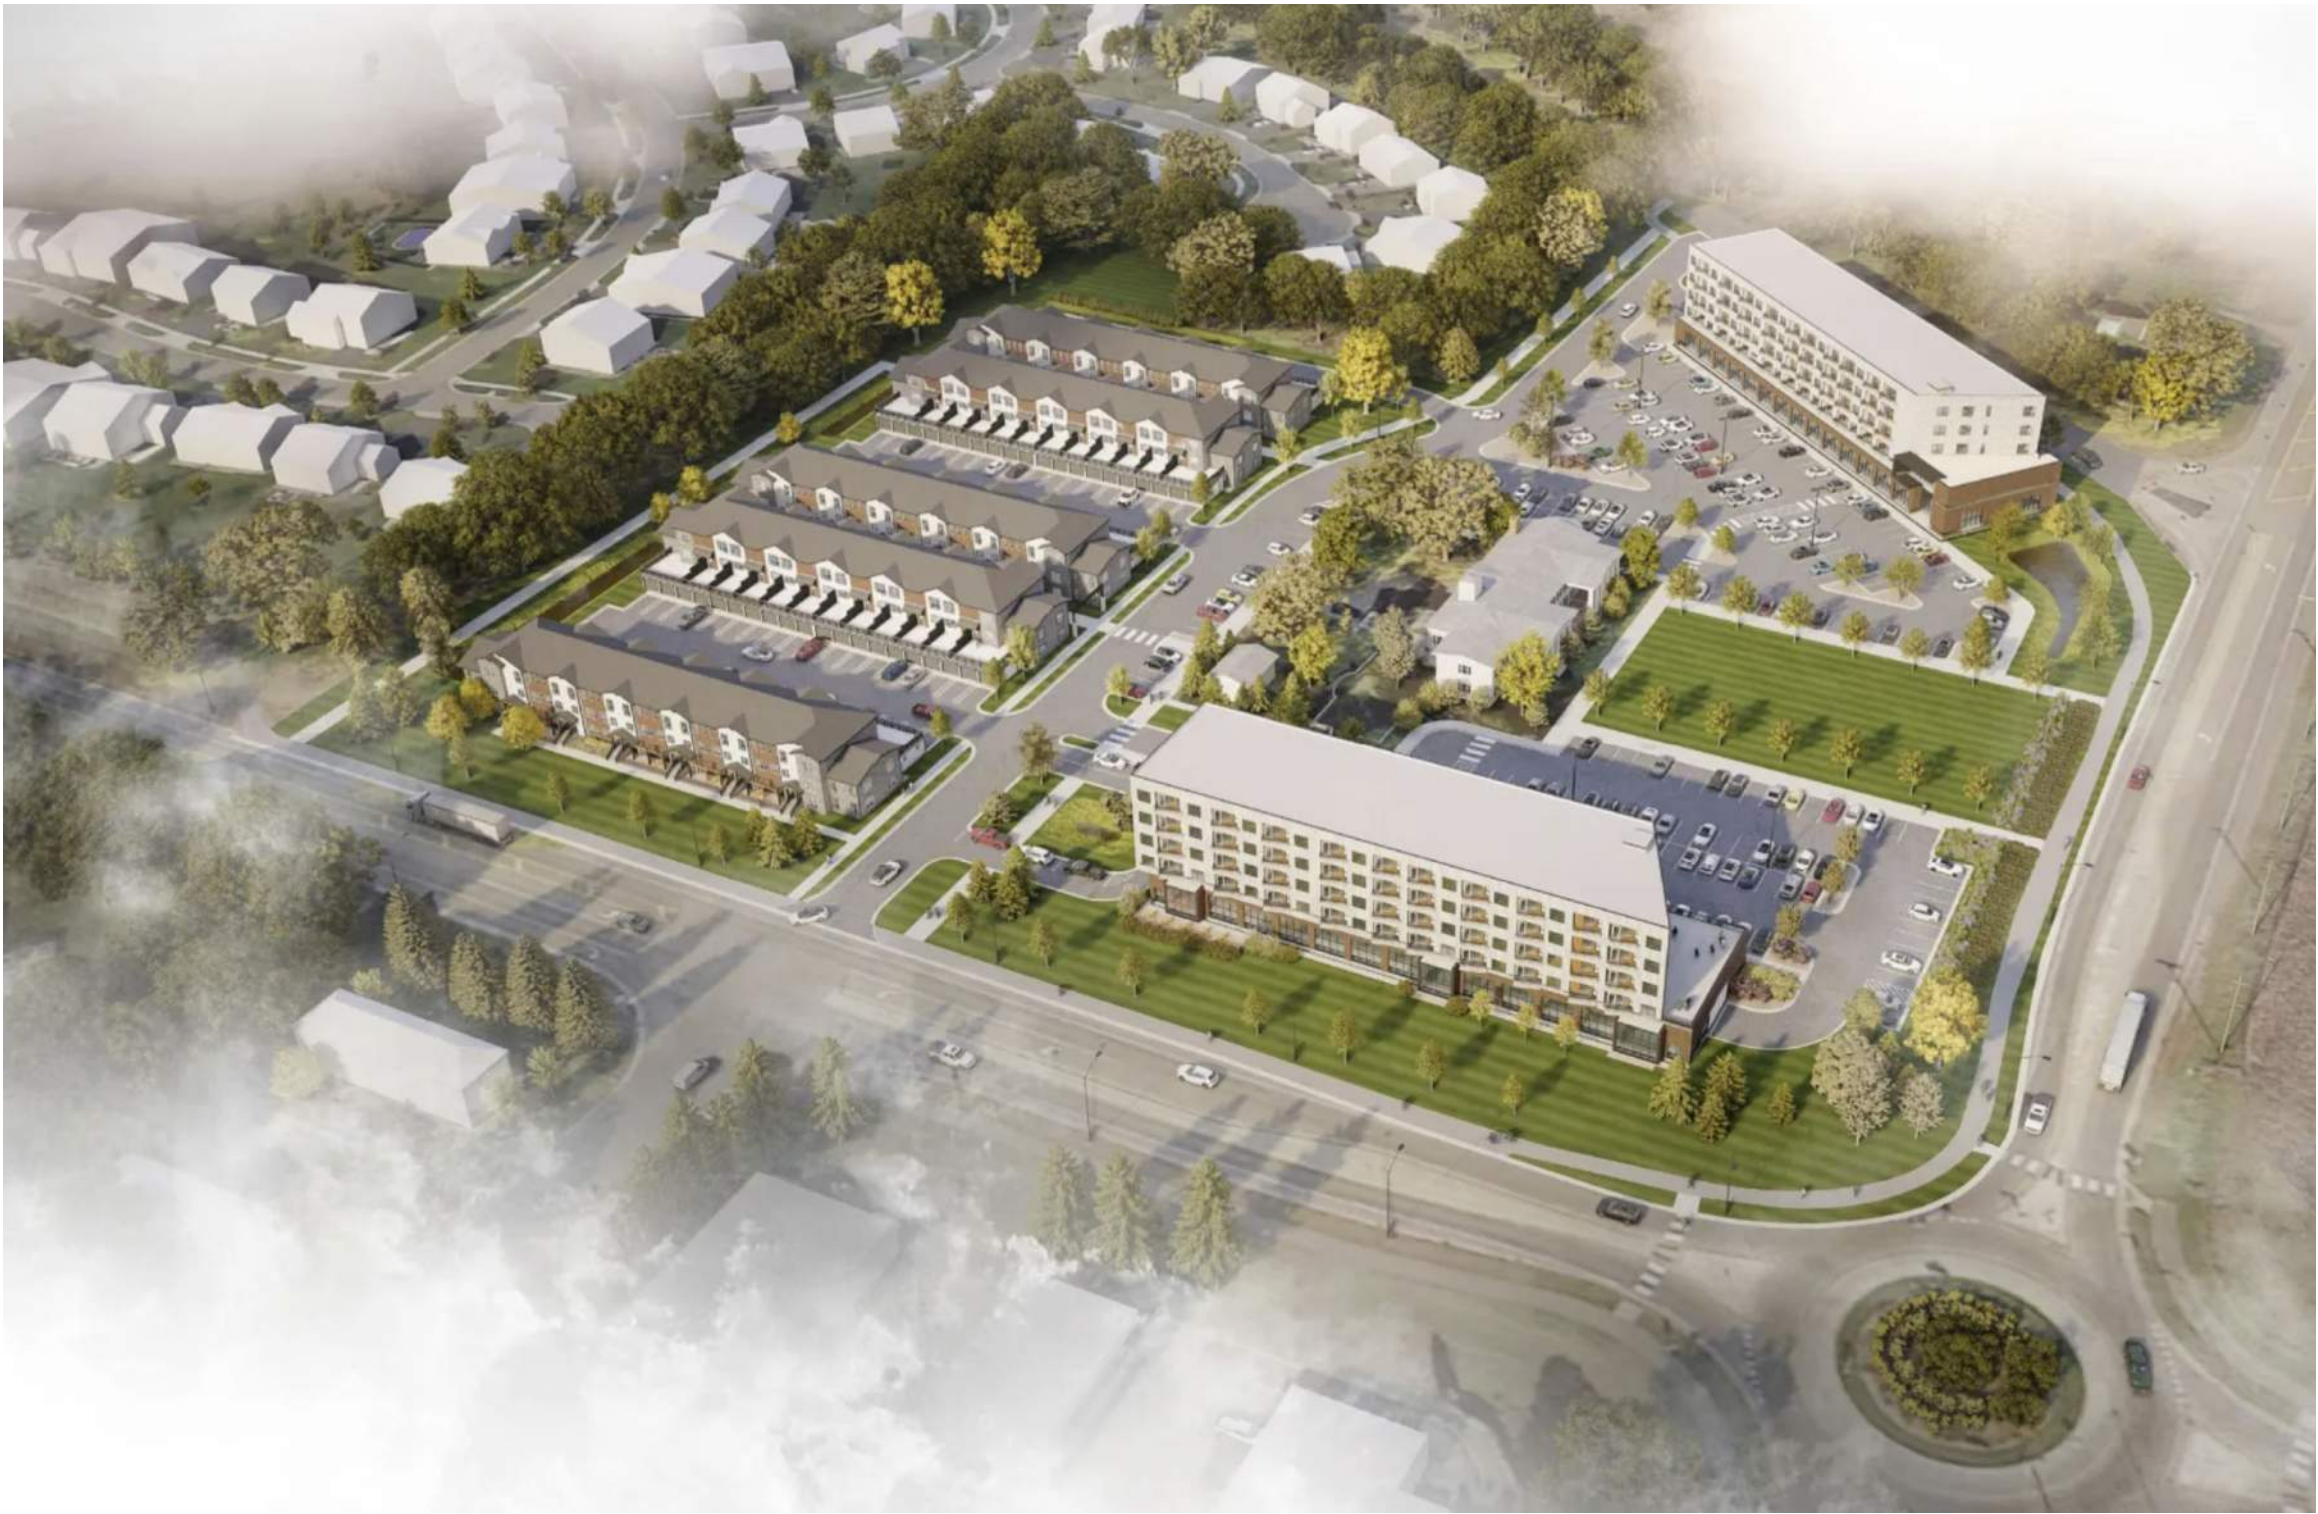
2022 REDEVELOPMENT PROPOSAL

A 2022 DEVELOPMENT PLAN **WIPES OUT** SURROUNDING SITE BUILDINGS THAT ARE IN GOOD REPAIR, **DESTROYS** A MAJORITY OF THE TREES ON THE SITE, **ELIMINATES** THE HISTORIC APPROACH, AND BLANKETS THE SITE WITH **IMPERVIOUS ASPHALT**.

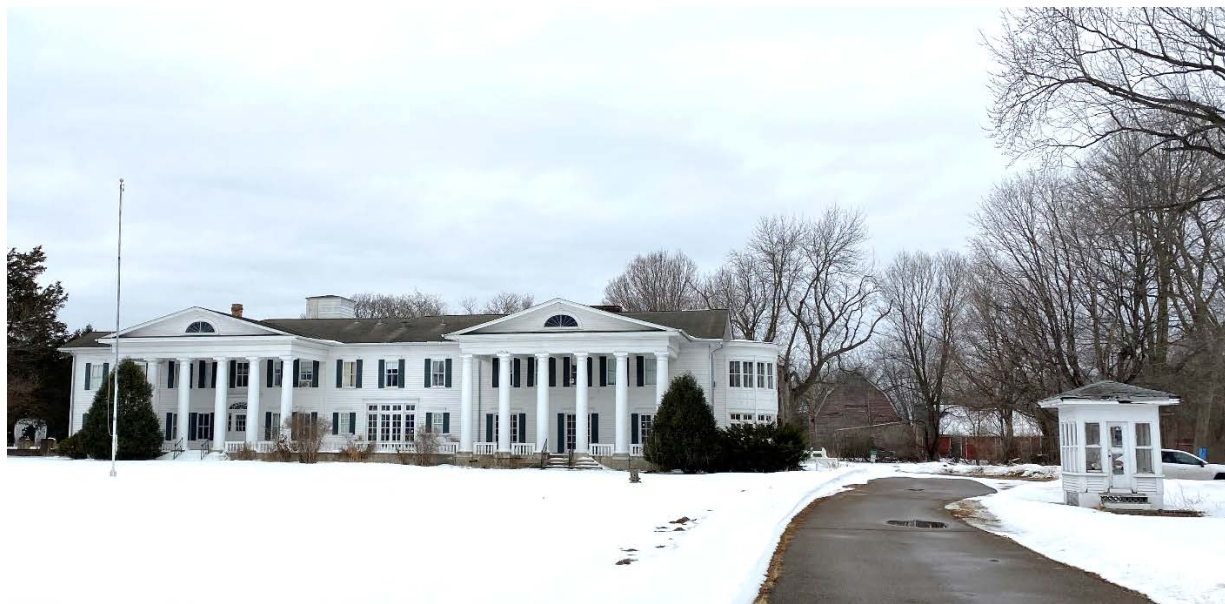
*Figure 1: View of the Cordenio Severance House and Valet Shelter, looking west.*

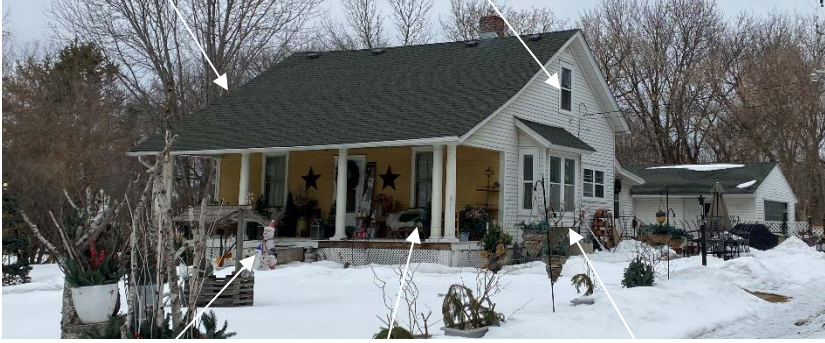
| Key Historic Features | | Orientation |
|---|--|---|
| <p>Gable roof      Rectangular window openings</p> <p>Porch with columns      Divided wood windows      Projecting window</p> | | <p>▲ True North<br/> — Primary façade<br/> - - - Secondary façade</p> |
| <ul style="list-style-type: none"> <li>• Rectangular building shape</li> <li>• Projecting window</li> <li>• Gable roof and dormer with overhanging eaves</li> <li>• Porch with columns</li> <li>• Exposed brick chimney</li> </ul> | | <ul style="list-style-type: none"> <li>• Non-enclosed porch configuration</li> <li>• North addition</li> <li>• Garage</li> </ul> |

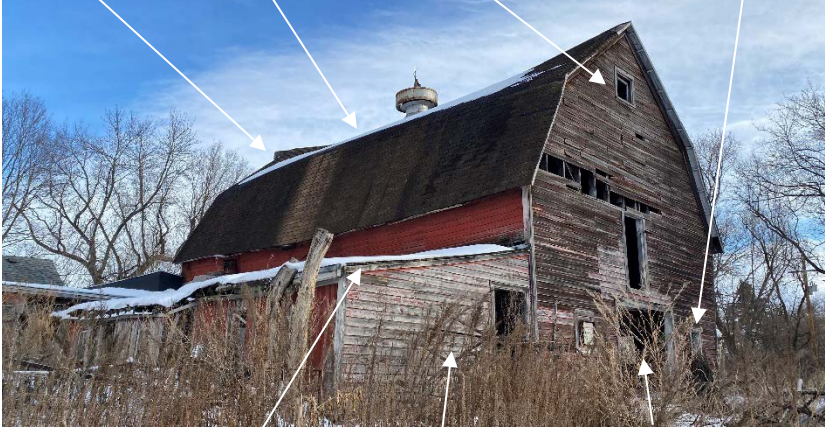
| Key Historic Features | | Orientation |
|---|--|---|
| <p>Track for pulley   Gambrel roof   Rectangular window openings   Divided wood windows</p> <p>Shed roof   Wood siding   Primary entrance</p> | | <p>▲ True North<br/> — Primary façade<br/> - - - Secondary façade</p> |
| <ul style="list-style-type: none"> <li>• Rectangular-shaped building</li> <li>• Gambrel roof with overhanging eaves, track for pulley, and vent</li> <li>• Shed-roofed north addition</li> <li>• Painted wood siding and trim</li> </ul> | | <ul style="list-style-type: none"> <li>• Glass block windows</li> <li>• East addition</li> </ul> |

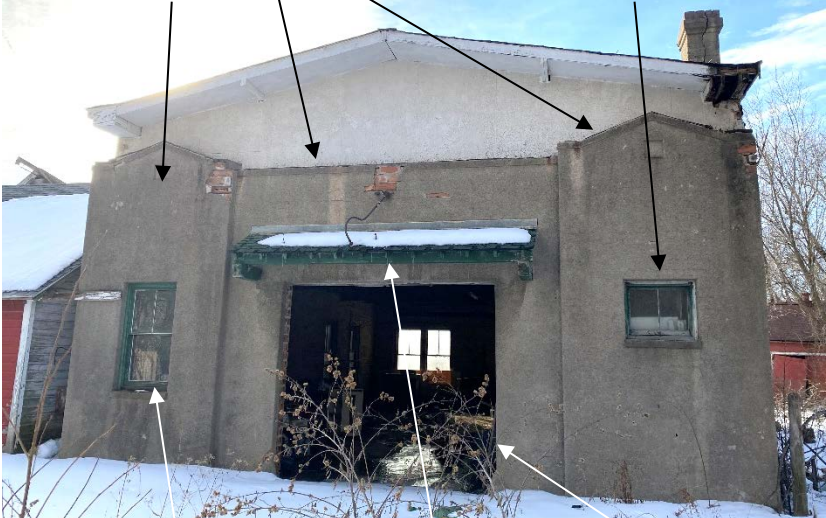
| Key Historic Features | | Orientation |
|---|--|---|
| <p>Stucco finish   Flat and sloped parapets   Rectangular window openings</p> <p>Divided wood windows   Wood overhang   Primary entrance</p> | | <p>▲ True North<br/> — Primary façade<br/> - - - Secondary façade</p> |
| <ul style="list-style-type: none"> <li>• Rectangular-shaped building</li> <li>• Flat and sloped roof (not extant) and parapets</li> <li>• Painted stucco finish</li> <li>• Wood overhang</li> <li>• Exposed brick chimney</li> <li>• Primary and secondary entrances</li> <li>• Punched rectangular window openings</li> <li>• Wood windows</li> </ul> | | <ul style="list-style-type: none"> <li>• Wood-framed gable roof</li> <li>• Plywood infill at secondary west entrance</li> </ul> |

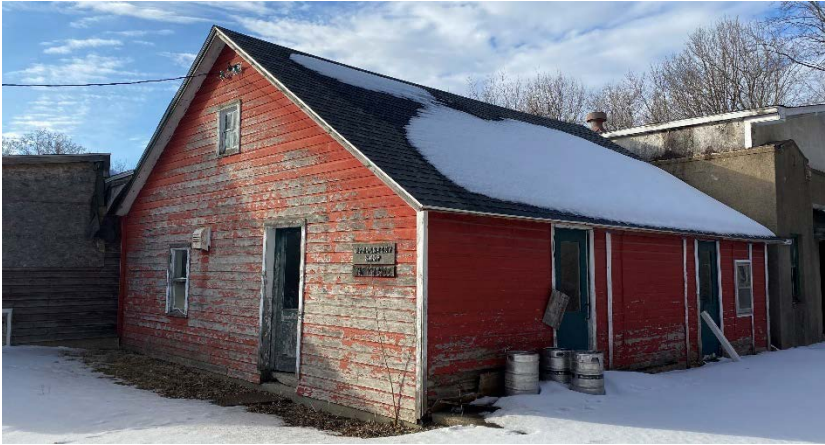
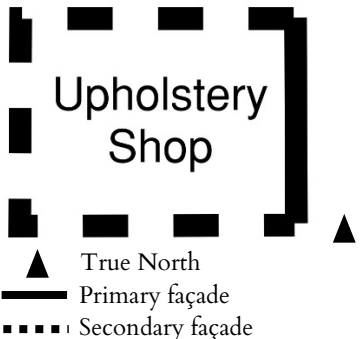
| Orientation | |
|---|---|
| | <ul style="list-style-type: none"><li>• Rectangular building</li><li>• Gable roof</li><li>• Wood siding</li><li>• Wood windows with storms</li><li>• Wood doors with half-light</li></ul> |

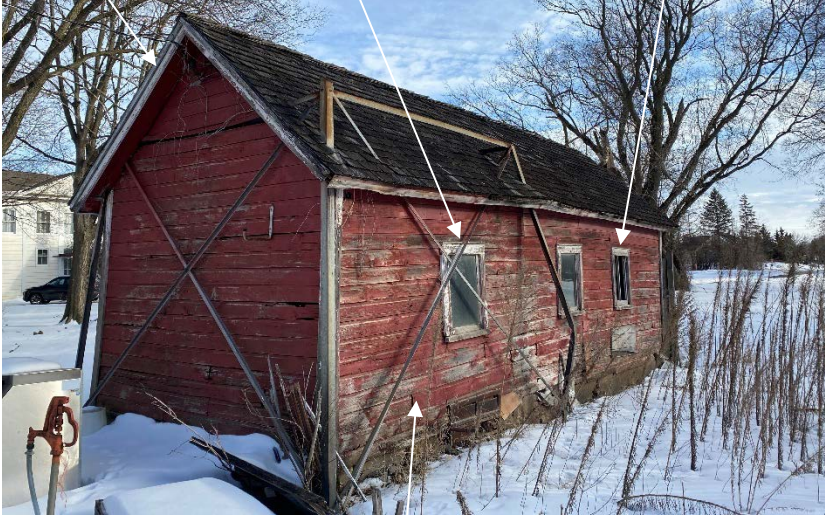
| Key Historic Features | | Orientation |
|---|--|---|
| <p>Gable roof      Rectangular window openings      Wood windows and doors</p> <p>Wood siding</p> | | <p>True North<br/>Primary façade<br/>Secondary façade</p> |
| <ul style="list-style-type: none"> <li>• Rectangular-shaped structure</li> <li>• Gable roof</li> <li>• Painted wood siding</li> <li>• Primary entrances</li> </ul> | | <ul style="list-style-type: none"> <li>• Metal framing for structural support</li> <li>• Light fixtures</li> </ul> |

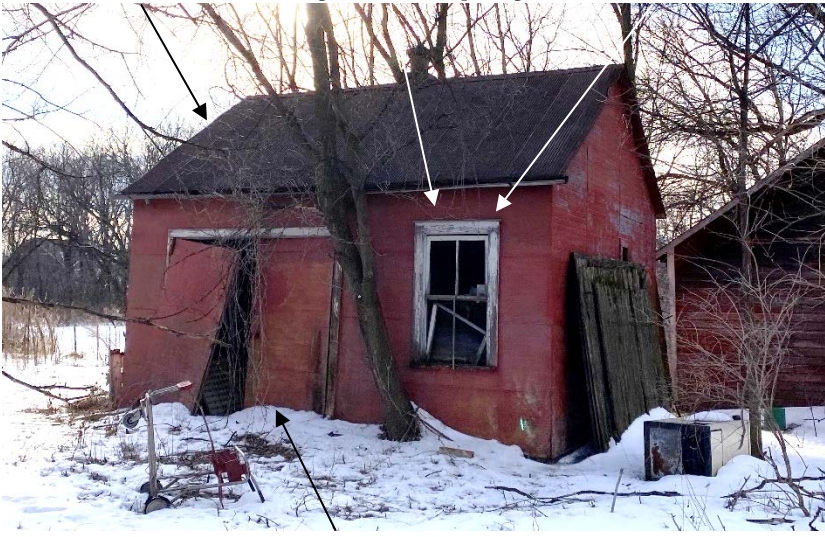
| Key Historic Features | | Orientation |
|---|--|---|
| <p>Gable roof      Rectangular window openings      Divided wood windows</p> <p>Wood doors</p> | | <p>Shed #1</p> <p>▲ True North<br/> — Primary façade<br/> ... Secondary façade</p> |
| <ul style="list-style-type: none"> <li>Rectangular-shaped structure</li> <li>Gable roof with vents</li> <li>Primary entrance</li> <li>Punched rectangular window openings</li> <li>Wood doors with trim</li> <li>Wood windows and trim</li> </ul> | | <ul style="list-style-type: none"> <li>Brick-looking metal sheet siding (façades and doors)</li> <li>Corrugated metal roofing</li> </ul> |

- 4.6.15. It is not recommended to create additional window openings at the Barn, Shed #1, or the Chicken Coop. Although not recommended, it might be acceptable to create a few appropriately-sized window openings at the north or east façades of the Barn, the north façade of Shed #1, or the north and south façades of the Chicken Coop.

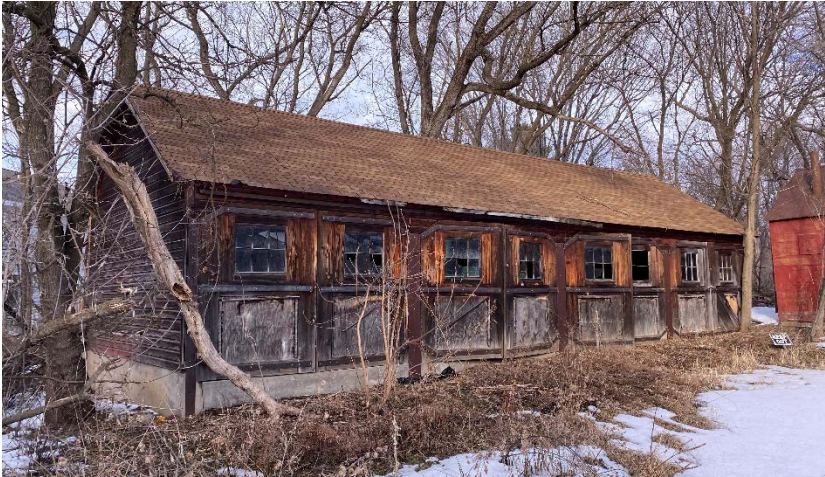
| Orientation | |
|---|---|
| | <p>Shed #2</p> <p>▲ True North<br/> — Primary façade<br/> - - - - Secondary façade</p> |
| | <b>Non-Historic Features (all)</b> <ul style="list-style-type: none"> <li>• Rectangular building</li> <li>• Gable roof</li> <li>• Wood siding</li> <li>• Wood doors with half-light</li> <li>• Concrete slab</li> </ul> |

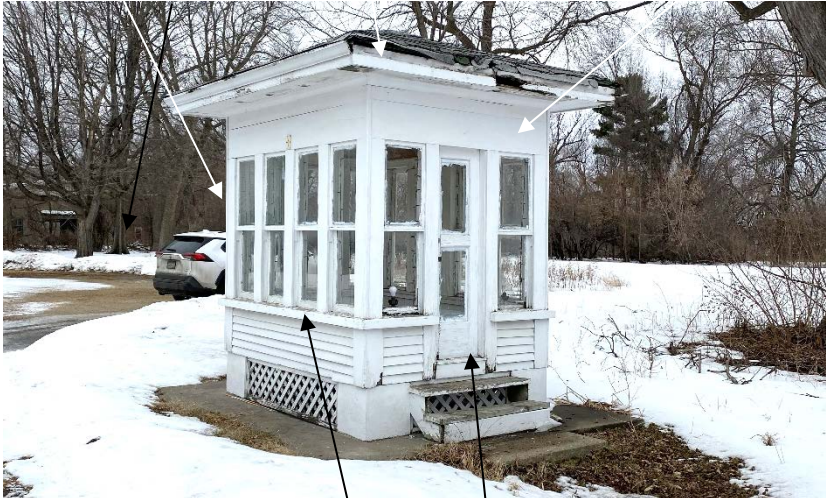
| Key Historic Features | | Orientation |
|---|--|---|
| <p>Square plan      Hipped roof with overhanging eaves      Wood siding</p> <p>Wood windows      Wood door</p> | | <p>The Valet Shelter is located on the northeast side of the Cordenio Severance House (see Fig. 2). This structure was formerly a cupola on the roof of the Cordenio Severance House.</p> |
| <ul style="list-style-type: none"> <li>Rectangular-shaped structure</li> <li>Hipped roof with overhanging eaves</li> </ul> | | <ul style="list-style-type: none"> <li>Concrete slab</li> </ul> |

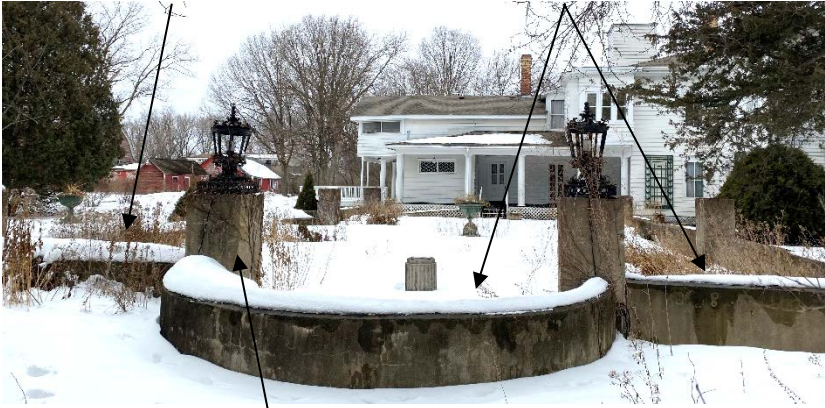
| Key Historic Features | | Orientation |
|---|--|---|
| <p>Partial-height concrete walls</p> <p>Straight and curved walls</p> <p>Square posts</p> | | <p>The Garden Wall is located on the southwest side of the Cordenio Severance House (see Fig. 2)</p> |
| <ul style="list-style-type: none"> <li>• Straight and curved walls</li> <li>• Partial-height concrete walls with square posts</li> </ul> | | <ul style="list-style-type: none"> <li>• Concrete slab</li> </ul> |

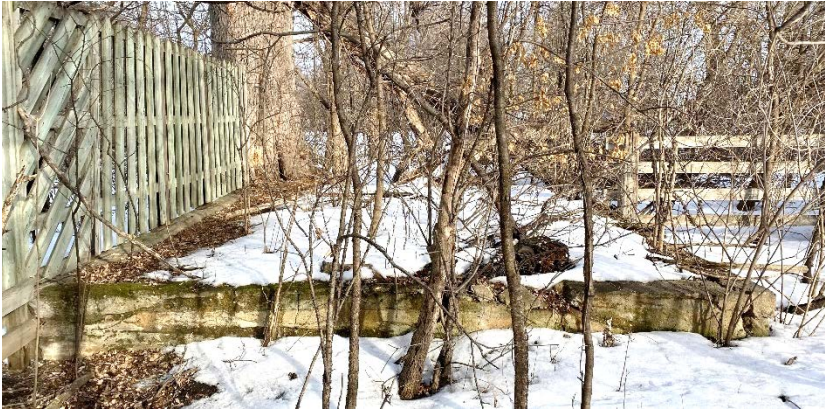
| Orientation | |
|---|---|
| | <p>The Ice House Foundation is located on the north side of the Garage (see Fig. 2)</p> |
| | <p><b>Non-Historic Features (all)</b></p> <ul style="list-style-type: none"><li>• Stone/concrete rubble foundation</li></ul> |
