**Title** Workshop – Cordenio Severance House (Cedarhurst) Proposed Event Center

**Staff Recommendation** Receive an overview of the proposed rehabilitation of the building and site located at 6940 Keats Avenue (Cedarhurst) for use as an event center.

# CEDARHURST MANSION REHABILITATION

Historical Site Design Guidelines  
Severance, Cordenio House [Cedarhurst]  
6940 Keats Avenue South  
Cottage Grove, Minnesota 55016

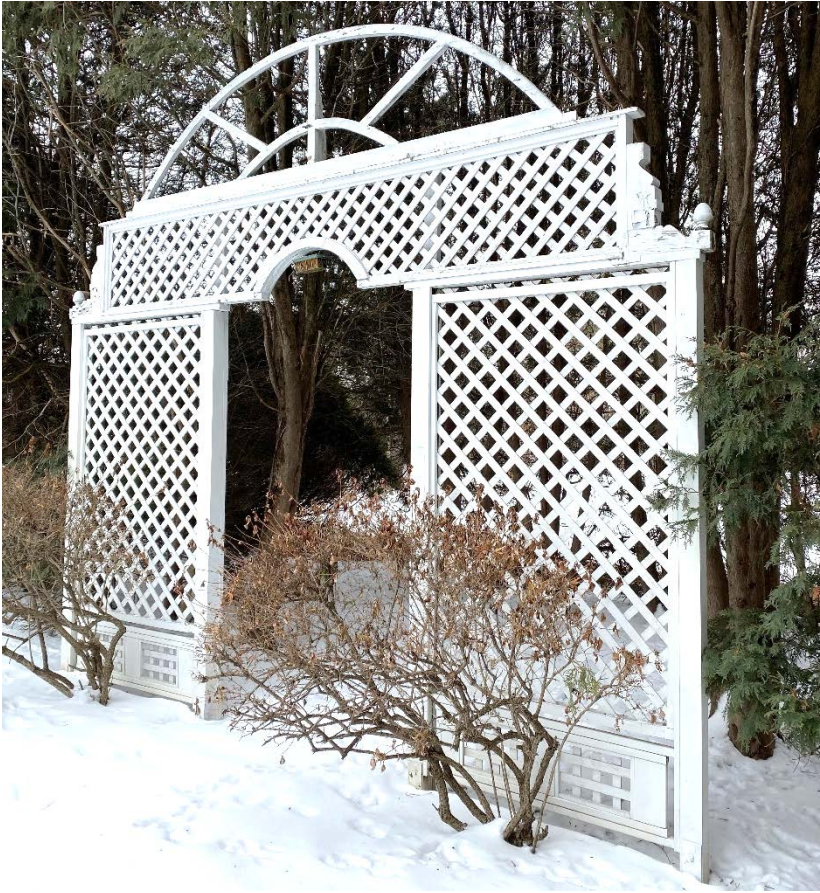
The Wood Trellis is located to the west of the Garden Wall (see Fig. 2)

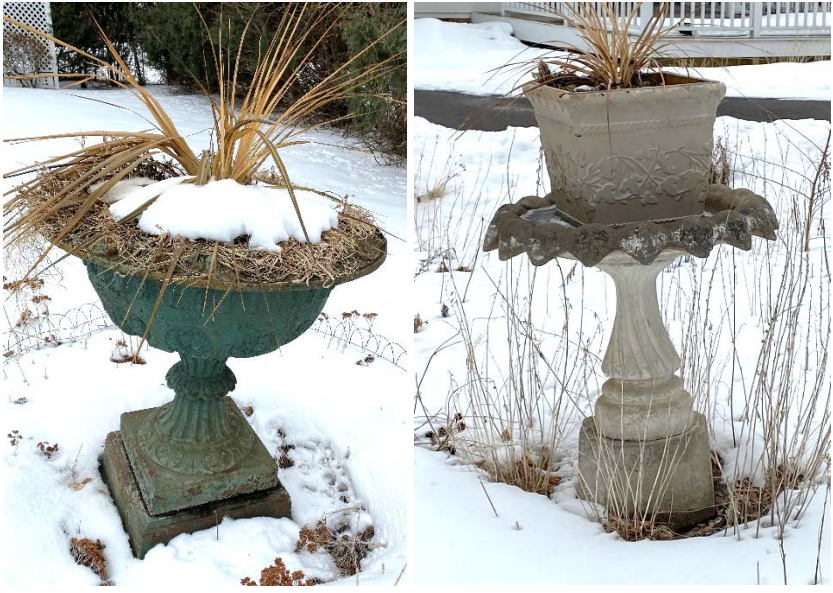
| Orientation | |
|---|---|
| Planters are located on the west side of the Cordenio Severance House and within/on the west side of the Garden Wall (see Fig. 2) | |

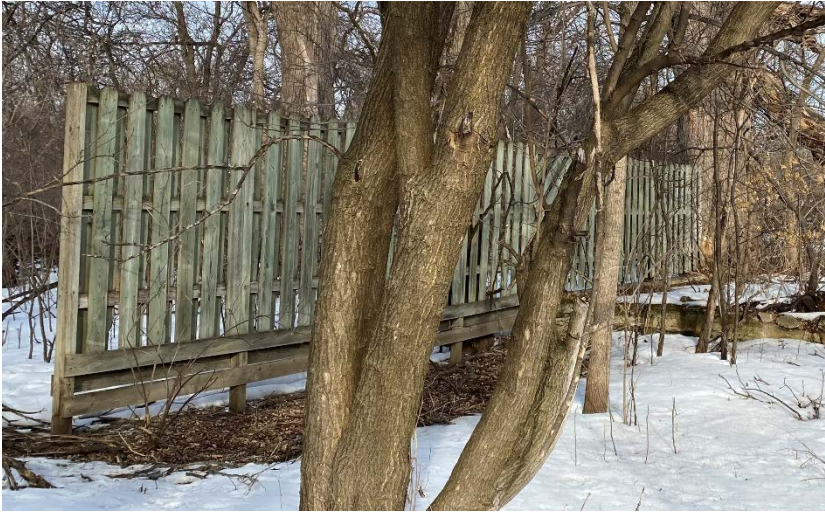
| Orientation | |
|---|---|
| | Wood fences are located on the east side of the Gardener's Cottage and at the Ice House Foundation (see Fig. 2) |
| | <ul style="list-style-type: none"><li>• Wood fences</li></ul> |
